**EXPLORATORY ARCHAEOLOGICAL INVESTIGATIONS AT PP7:
TO DETERMINE FEASIBILITY, STRATEGY & SCOPE FOR
REMEDIAL MITIGATION AND CONSERVATION**

**Erf 15387 and a portion of Erf 2001, Farm Boplaas, Pinnacle
Point, Mossel Bay District, Western Cape Province**

Final Report

8 October 2009

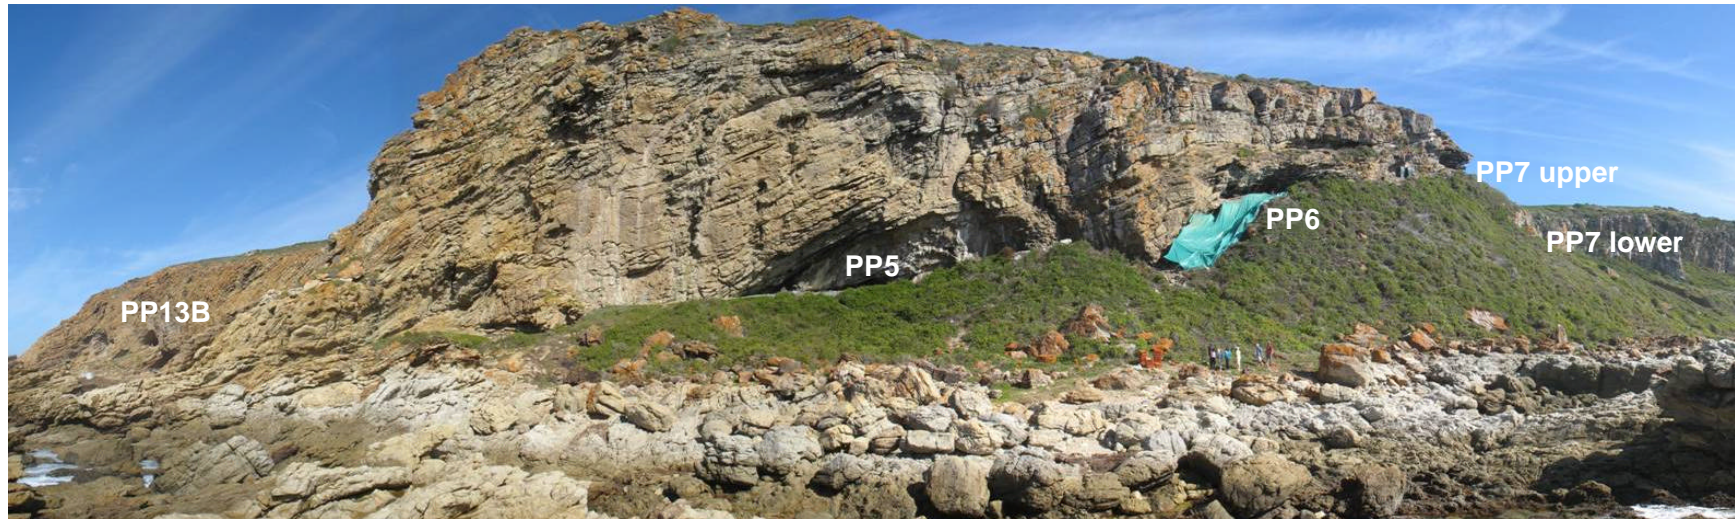
- PP7 upper and lower lie alongside the now renowned and globally significant archaeological site of PP6, and continued or future erosion is a great threat to these sites (Plate 1)
- below the rocky overhang of PP7 upper, the talus slopes steeply to the rocky shoreline below at an angle of greater than 30° (Plates 1, 2 & 6)

- the northern extent of PP7 is destroyed as evidenced by the near absence of shell midden materials in the northern erosion-cut profile
- a large portion of PP7 remains in tact and can be conserved (Plates 1 & 2)

Plate 1. Panorama toward SW and NE: PP7 relative to a few cave sites at Pinnacle Point. Note steepness of slope at PP7.

- protection and conservation of the remaining archaeological deposits at PP7 and potentially PP6 will require effective, permanent stabilization of the erosion donga in the near future

- no further archaeological mitigation should be conducted at PP7
- in lieu of archaeological mitigation, the focus should be on stabilizing the donga to prevent further erosion of sediments, vegetation and midden deposits
- a suitable engineer should be appointed - as a matter of urgency - to devise an effective strategy to stabilize PP7 and to prevent further erosion

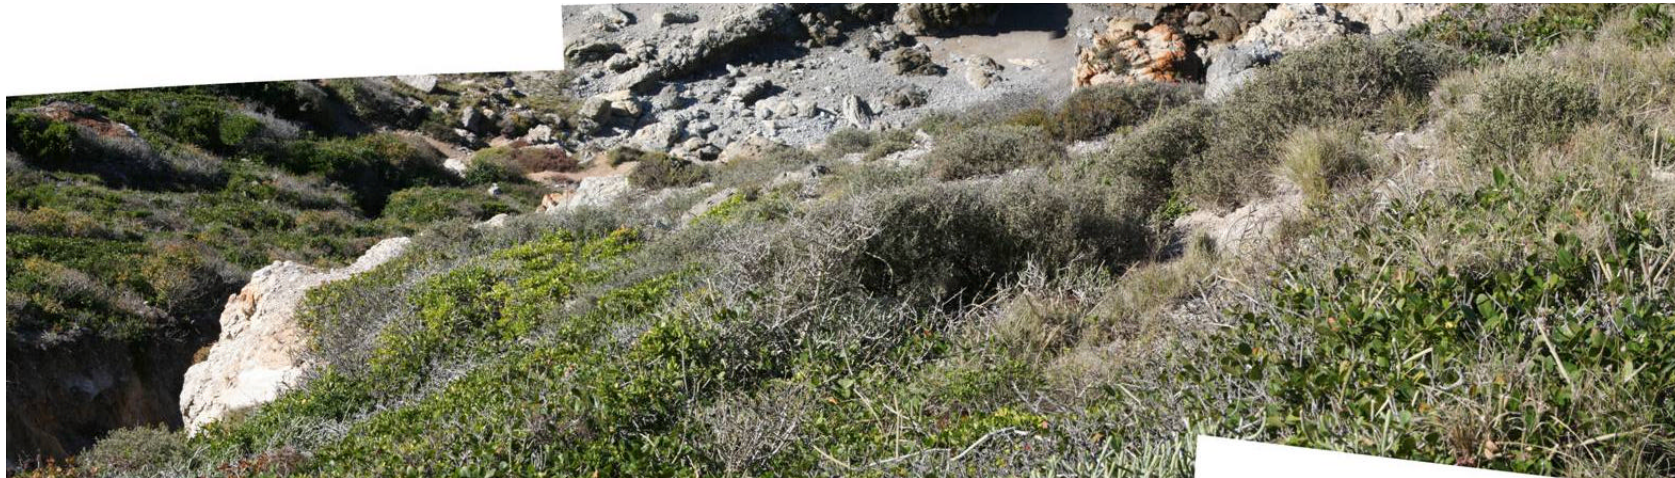
Plate 2. Looking down talus slope from PP7 upper – note steepness of slope and erosion donga at bottom left of image.

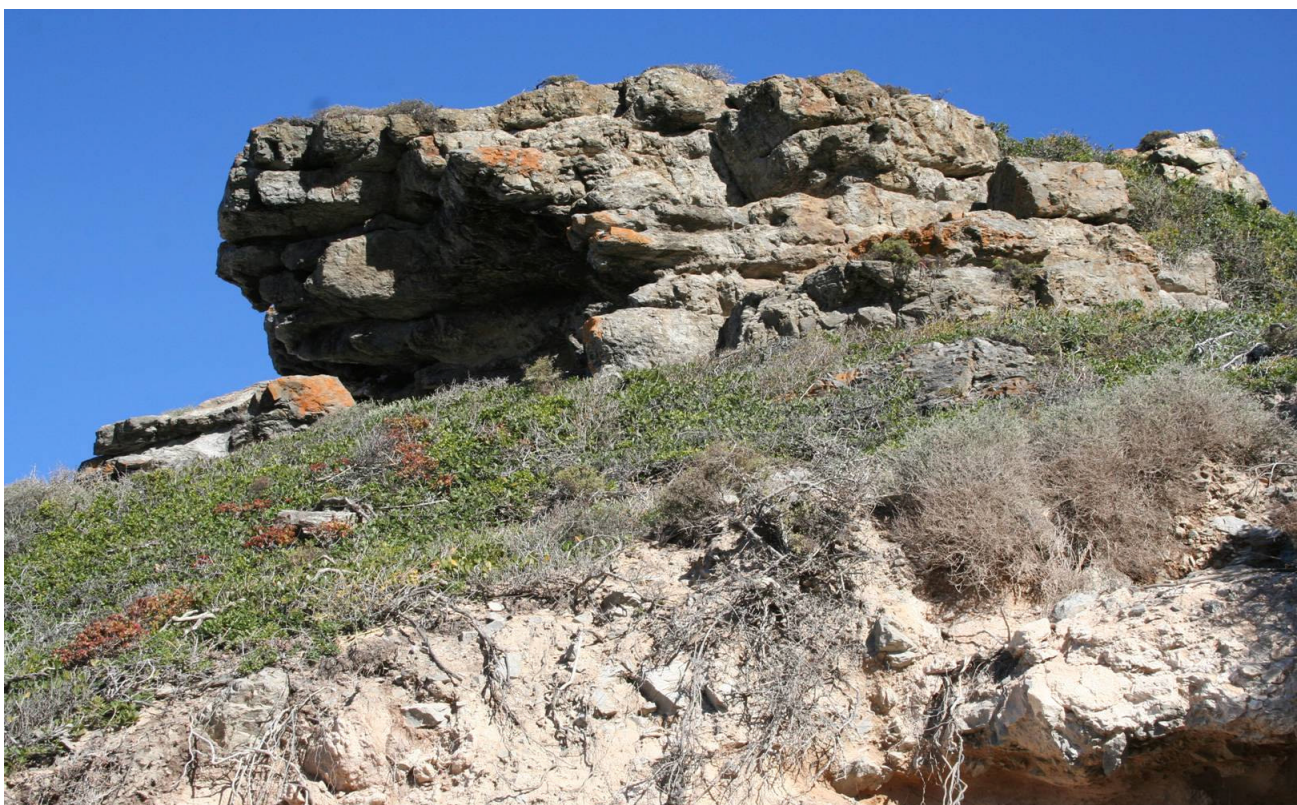
- a substantial part of PP7 lower is ruined by erosion (see Table 1 for coordinate data for PP7 and the erosion gully; see Plates 6 through 7)
- PP7 upper is less affected and is largely in tact (Plate 4)

Plate 4. Southern edge of donga with rock shelter of PP7 upper

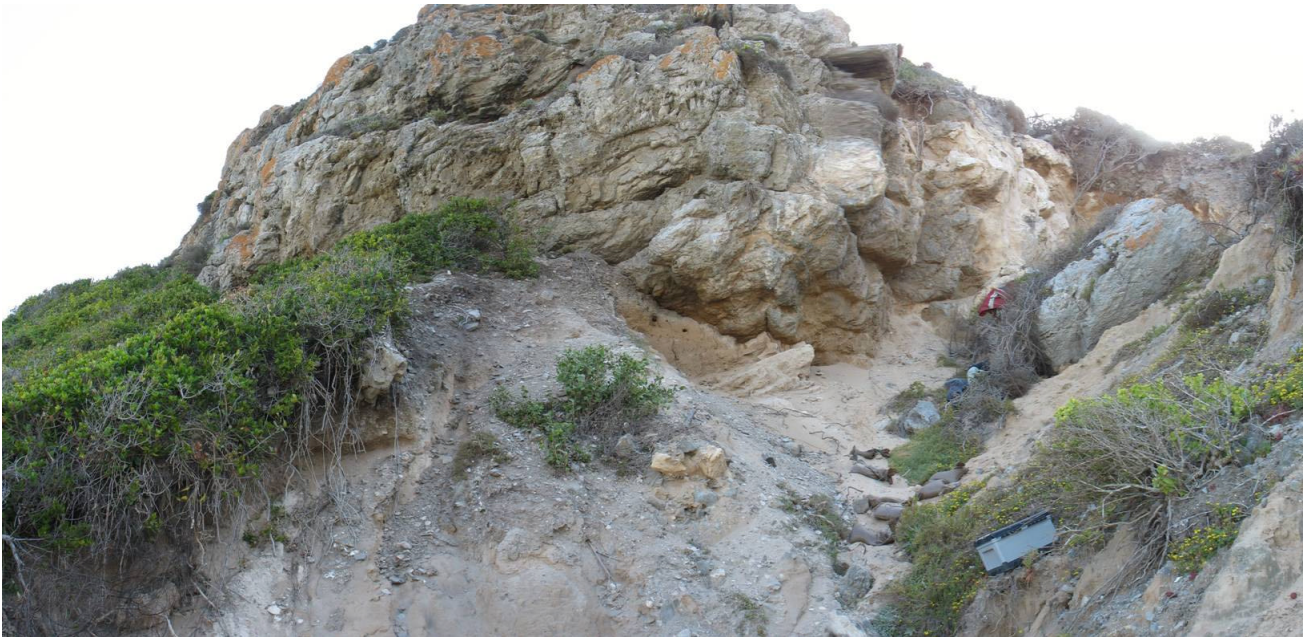
Plate 5. Upper reaches of donga with archaeological debris on southern wall of erosion gulley

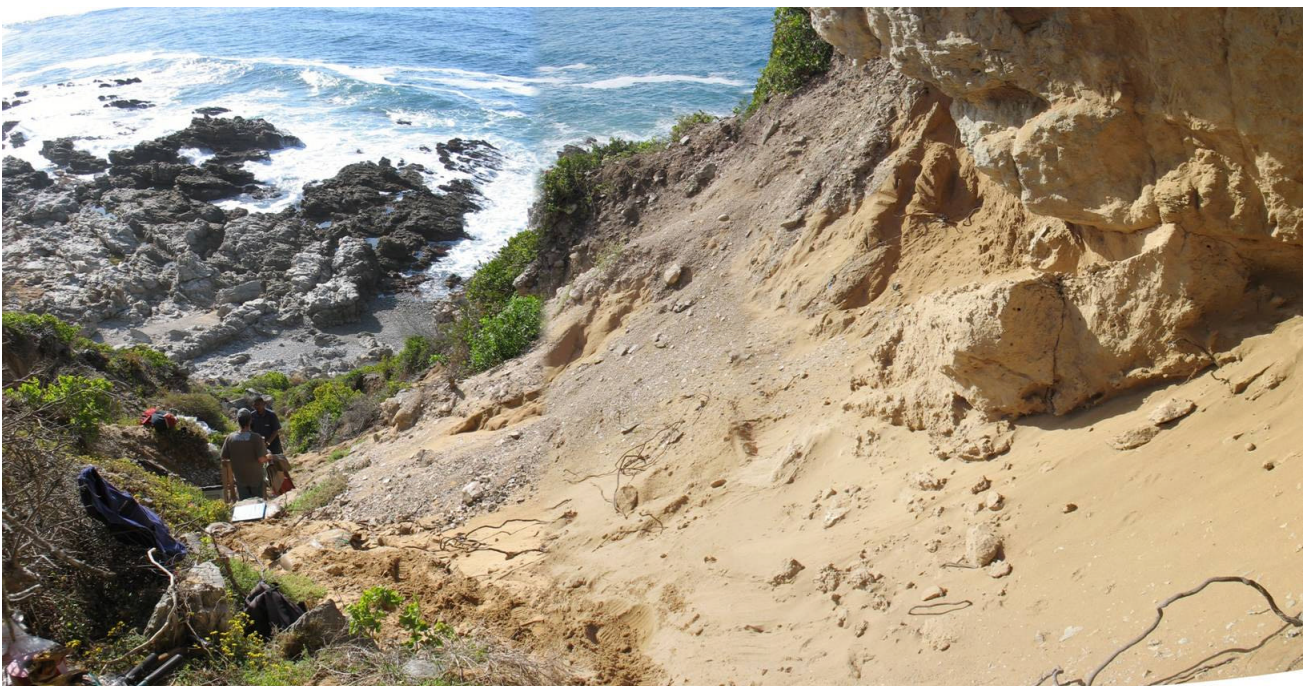
Plate 6. Looking down from upper part of donga with crew screening cleared sediments at centre left

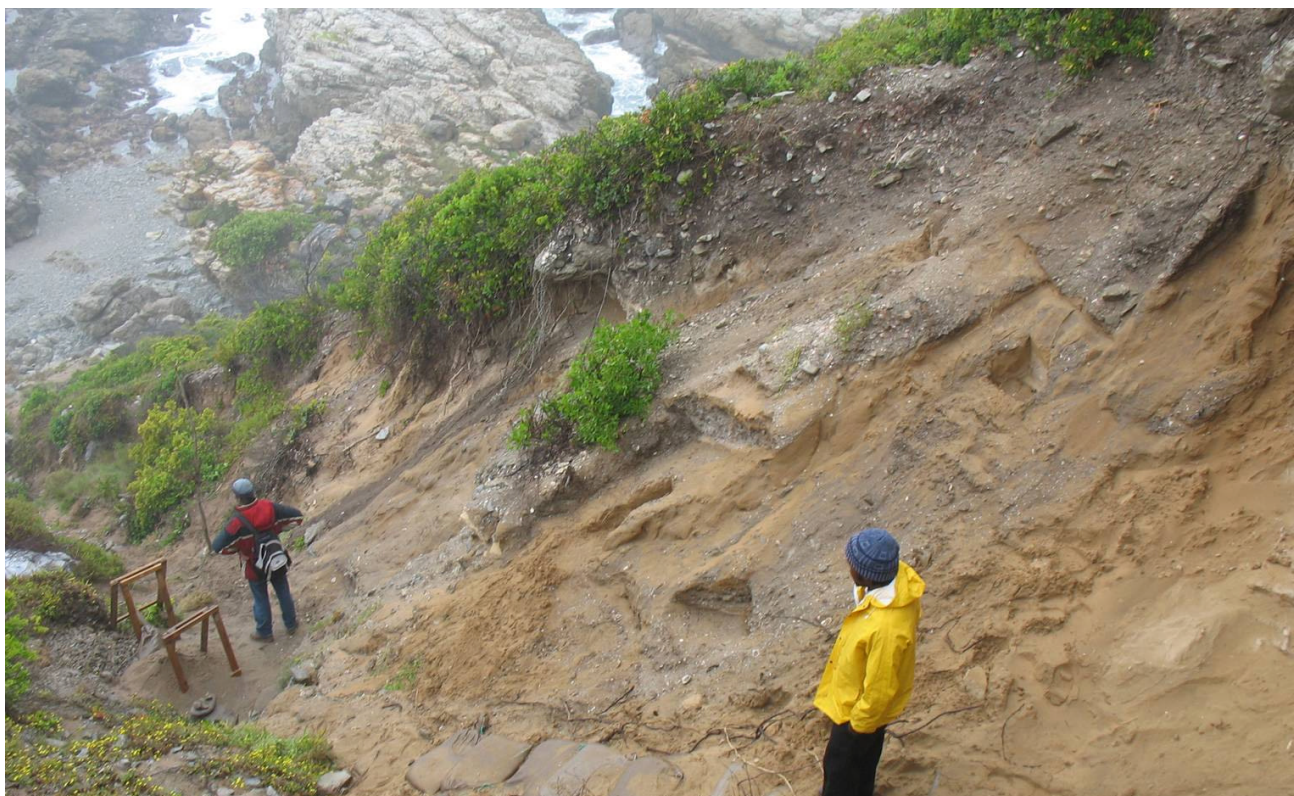
- some sections of archaeological deposits visible in the erosion-cut, southern profile show that, in places, the steep talus slope below the small overhang resulted in considerable mixing of materials as they migrated and settled down slope (Plate 7)

- some small test holes revealed the presence of in tact shell midden layers in aeolian dune sands below the upper midden deposits up to a depth of at least 2 m below the surface – while no stone artifacts were seen in these small exposures of the lower lenses, it is possible that they are of Middle Stone Age origin (Plates 7 & 8)

Plate 7. End of 6th day in field; note a few of the small test holes with archaeological deposits

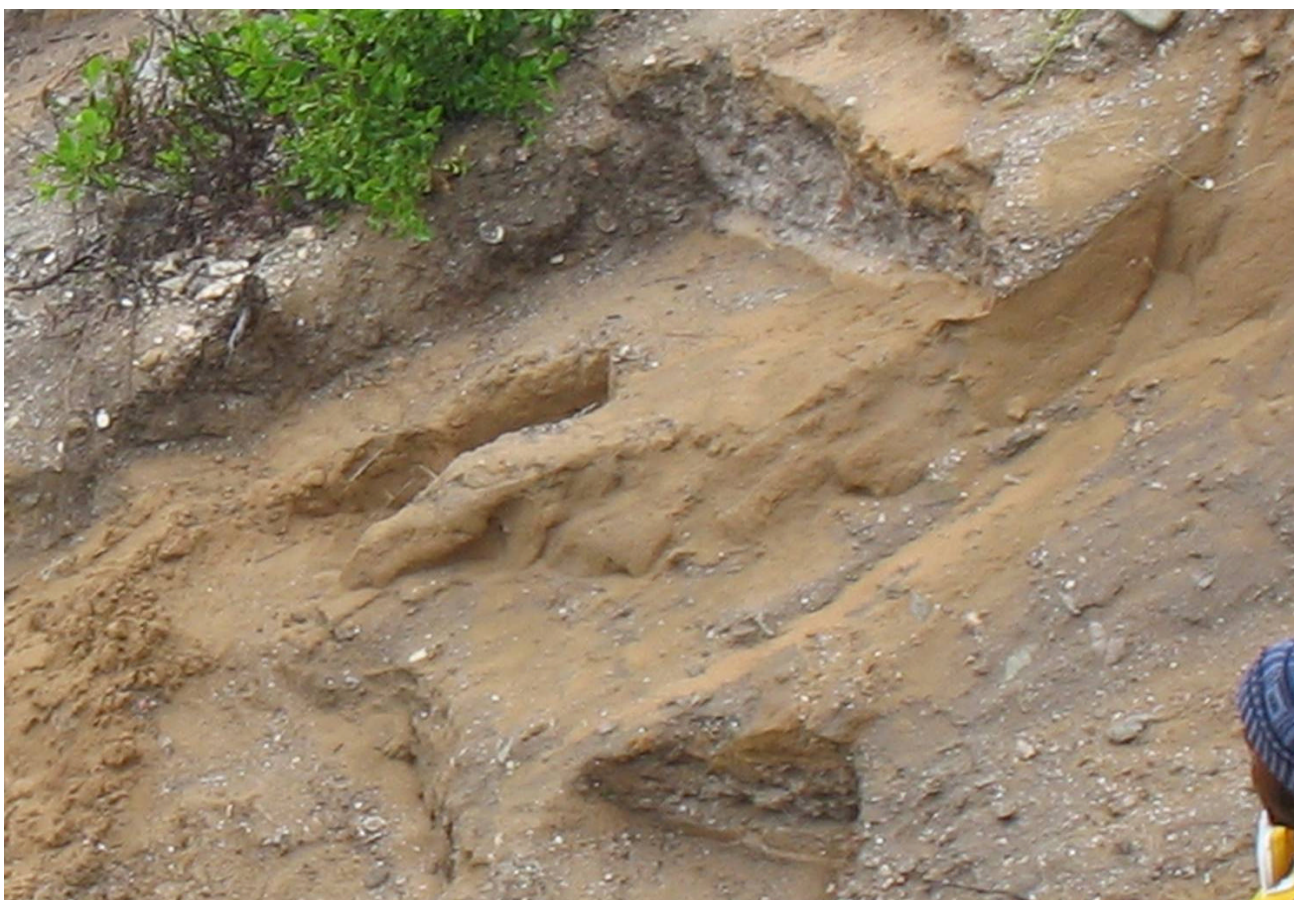
- the lower shell midden layers are in tact, stratified and well bedded and would likely yield more valuable information than the partially mixed, compromised upper midden deposits

Plate 8. Close up of test holes with archaeological layers; the lower shell midden layer is at least 2 m below the surface
