Archaeological Impact Assessment

Construction of Sewer Pipelines for Mossdustria and Erf 6422, District Mossel Bay, Western Cape Province

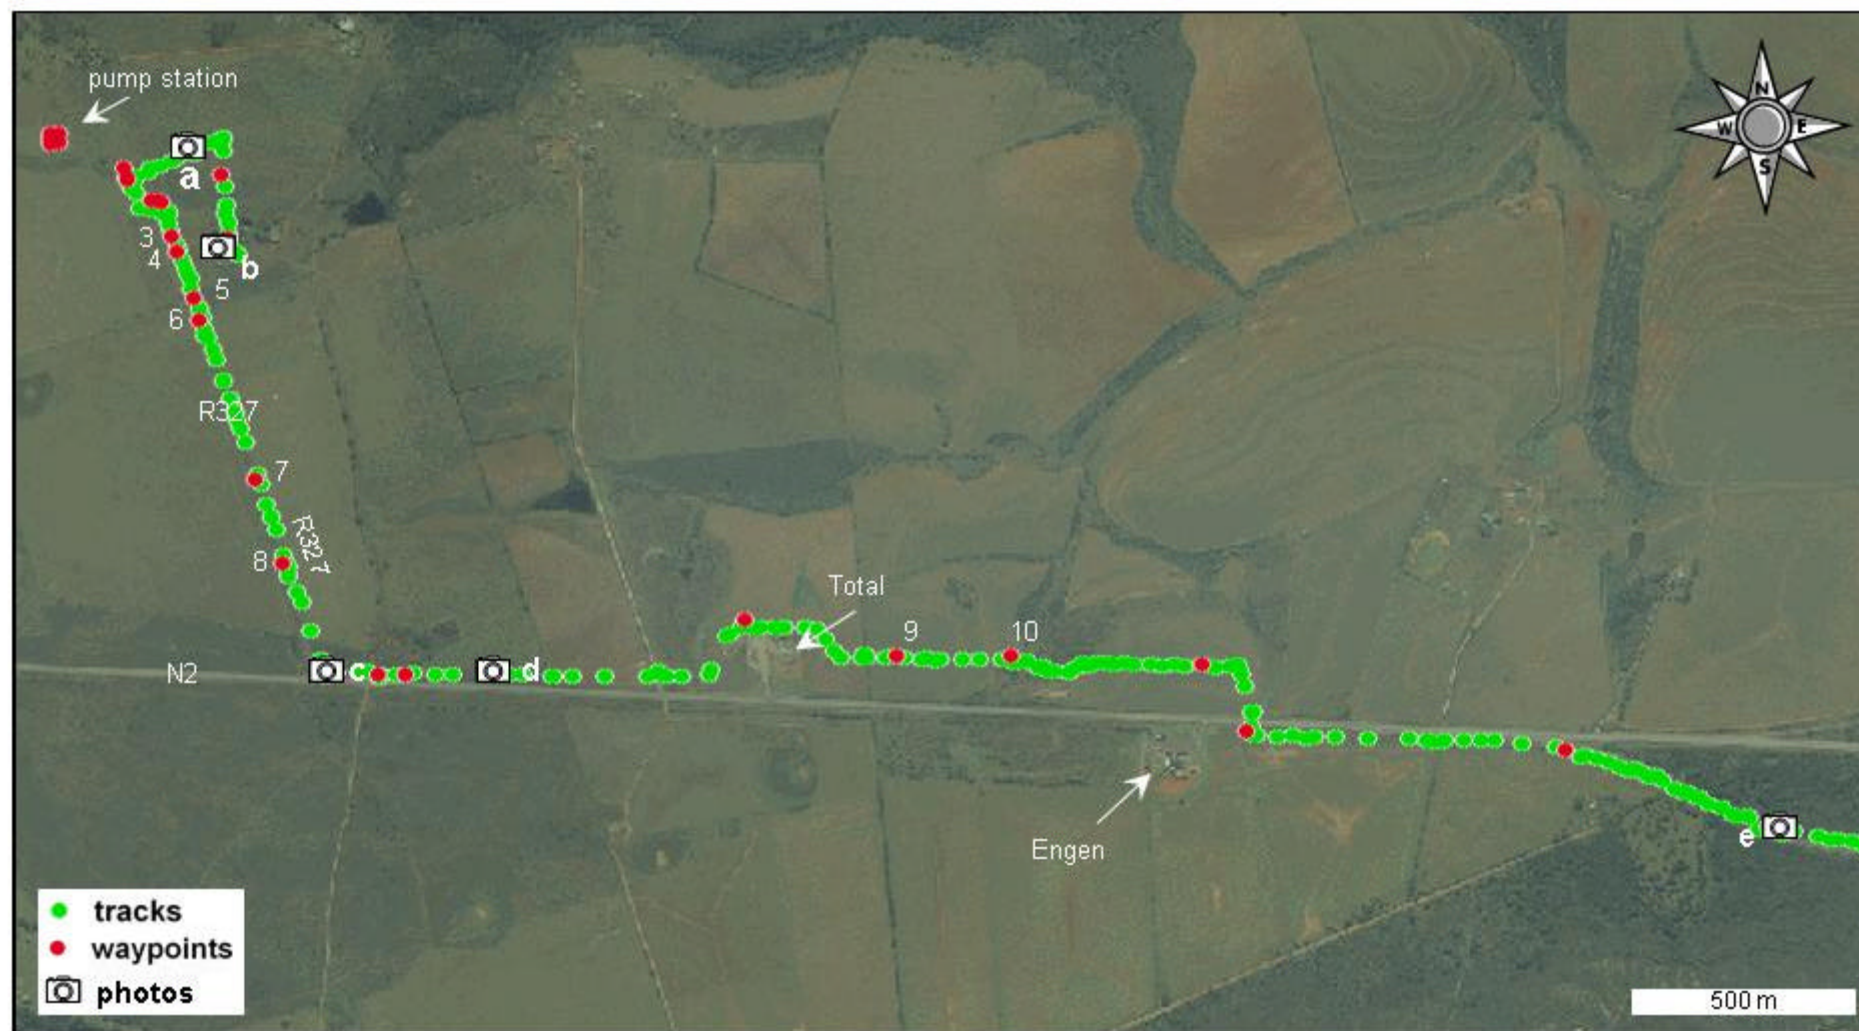
Figure 5. Enlarged area as indicated in Figure 2 showing survey tracks and waypoints representing archaeological occurrences, observations and photo localities (red dots and camera icons). Lower case letters associated with camera icons indicate direction of views shown in Plates 1 and 3. Numbered red dots indicate locations of archaeological occurrences shown in Plates 1 through 3.

towards Mossel Bay, turns South near a dump site and runs towards the Pinnacle Point WWTW (see Figures 2, 5 & 6). Note that the pipeline route – indicated in blue – is mostly obscured by the overlay of walk tracks and waypoints. The original pipeline alignment where it turns toward the Pinnacle Point WWTW is changed to run adjacent to the existing single vehicle, unpaved track.

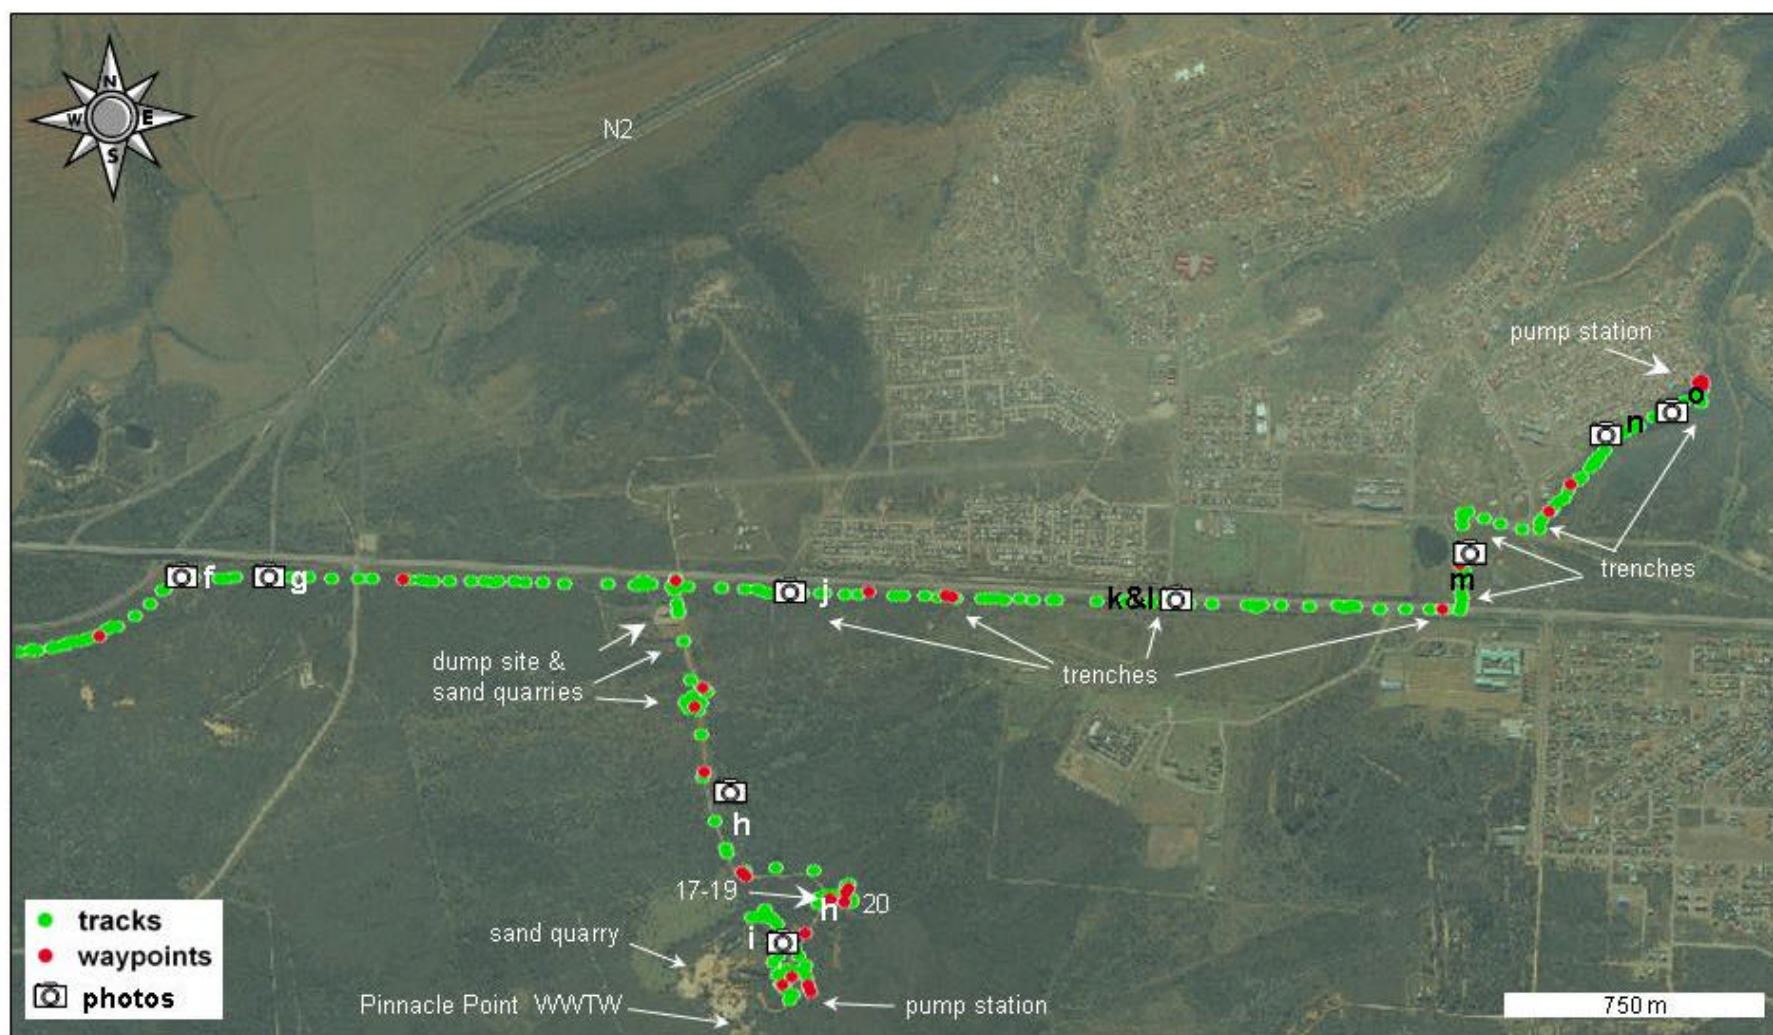
Figure 6. Enlarged area as indicated in Figure 2 showing survey tracks and waypoints representing archaeological occurrences, observations and photo localities (red dots and camera icons). Lower case letters associated with camera icons indicate direction of views shown in Plates 1 and 3. Red dots with numbers indicate locations of archaeological occurrences shown in Plates 1 through 3.

Observations of relevance comprise stone artifacts originating in the Stone Age and these are overwhelmingly dominated by Early Stone Age (ESA) material with a few Middle Stone Age (MSA) implements occurring in the southern extent of the study area centered on waypoints 17 through 20 (Figure 6 and Plates 2 & 3). Coordinate data in Table 1 and Figures 5 and 6 give locality information while Plates 1 through 3 show examples of identified specimens. Only a representative sample of recorded occurrences is presented and no *in situ* material was seen. A full data set of recorded material is available on request.

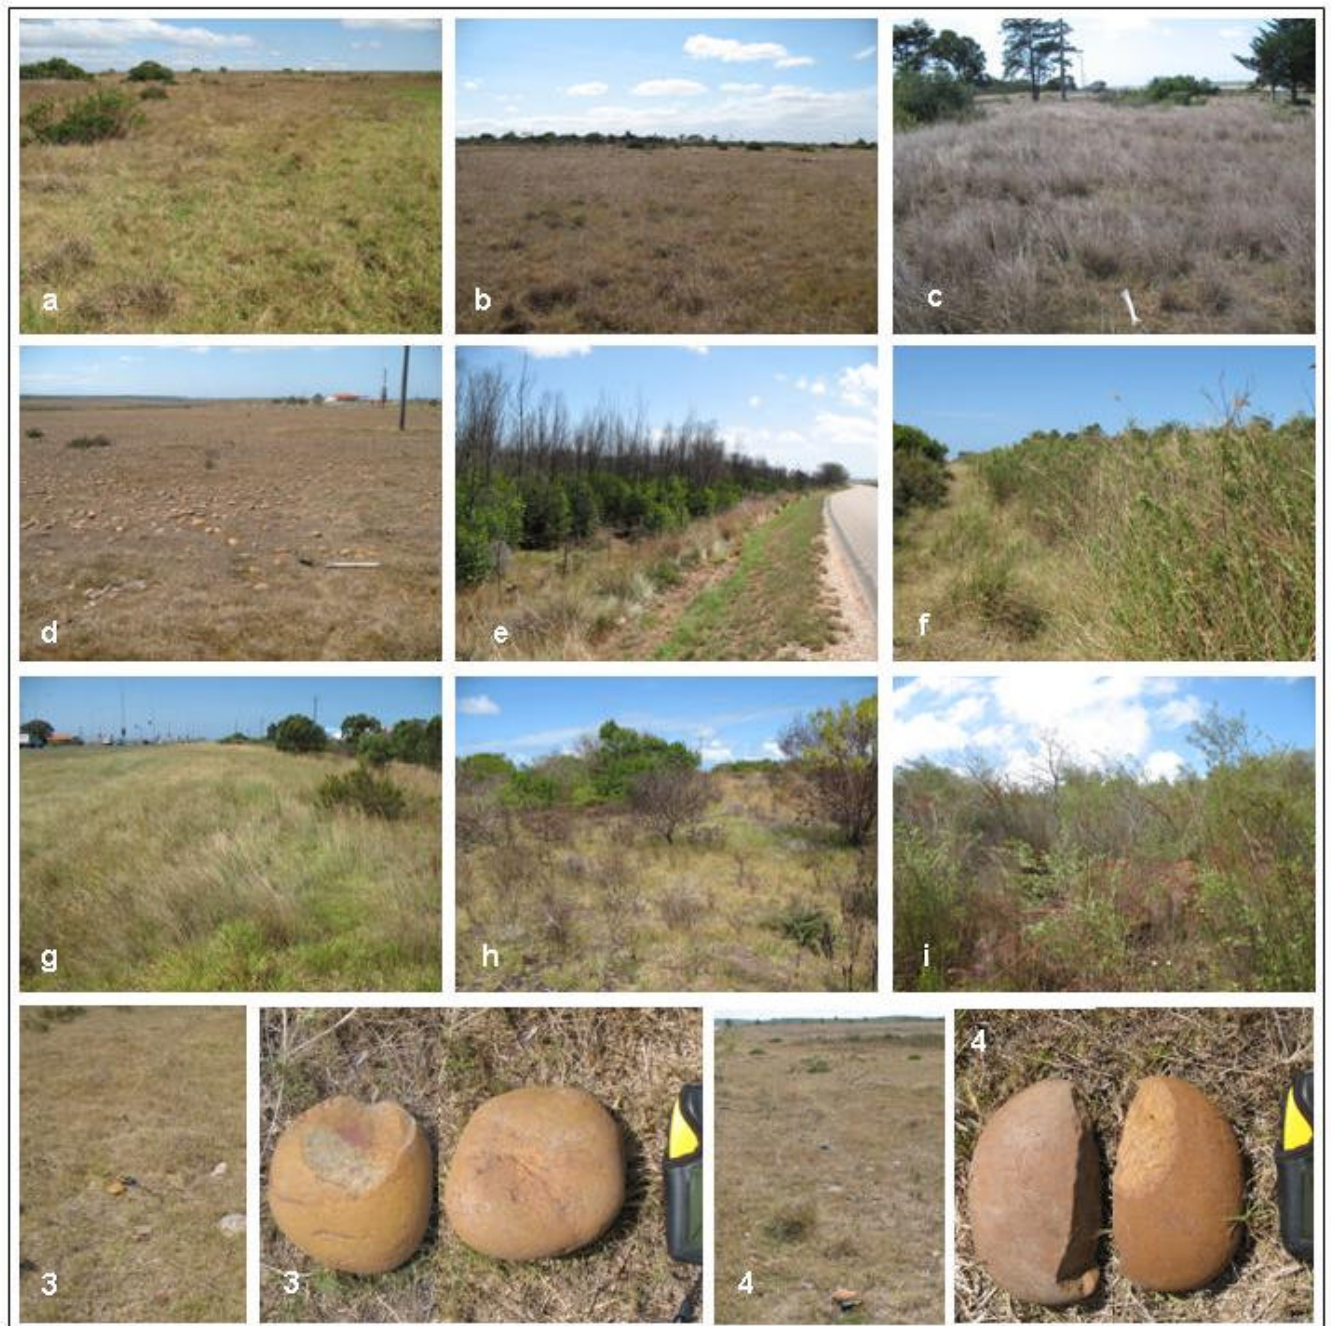
ESA implements include hammer stones, a variety of unifacial and bifacial cores, flakes, chunks, choppers and/or damaged hammer stones, cleavers as well as unifacial and bifacial hand axes (Plates 1 through 3). The MSA is represented by a disc core, flakes and a retouched flake-blade (Plates 2 & 3). Most artifacts are in quartzite, but a few quartz and silcrete specimens of indeterminate age were also seen.

Plate 1. Images a through i show varied vegetation type and cover – also seen in numbered photos of observation contexts - in the study area. Numbered images show context and close-ups of archaeological – 2 views - and other observations. See Figures 5 and 6 for position and orientation of photographs. Garmin Camo hand held GPS as scale for the view closest to it.

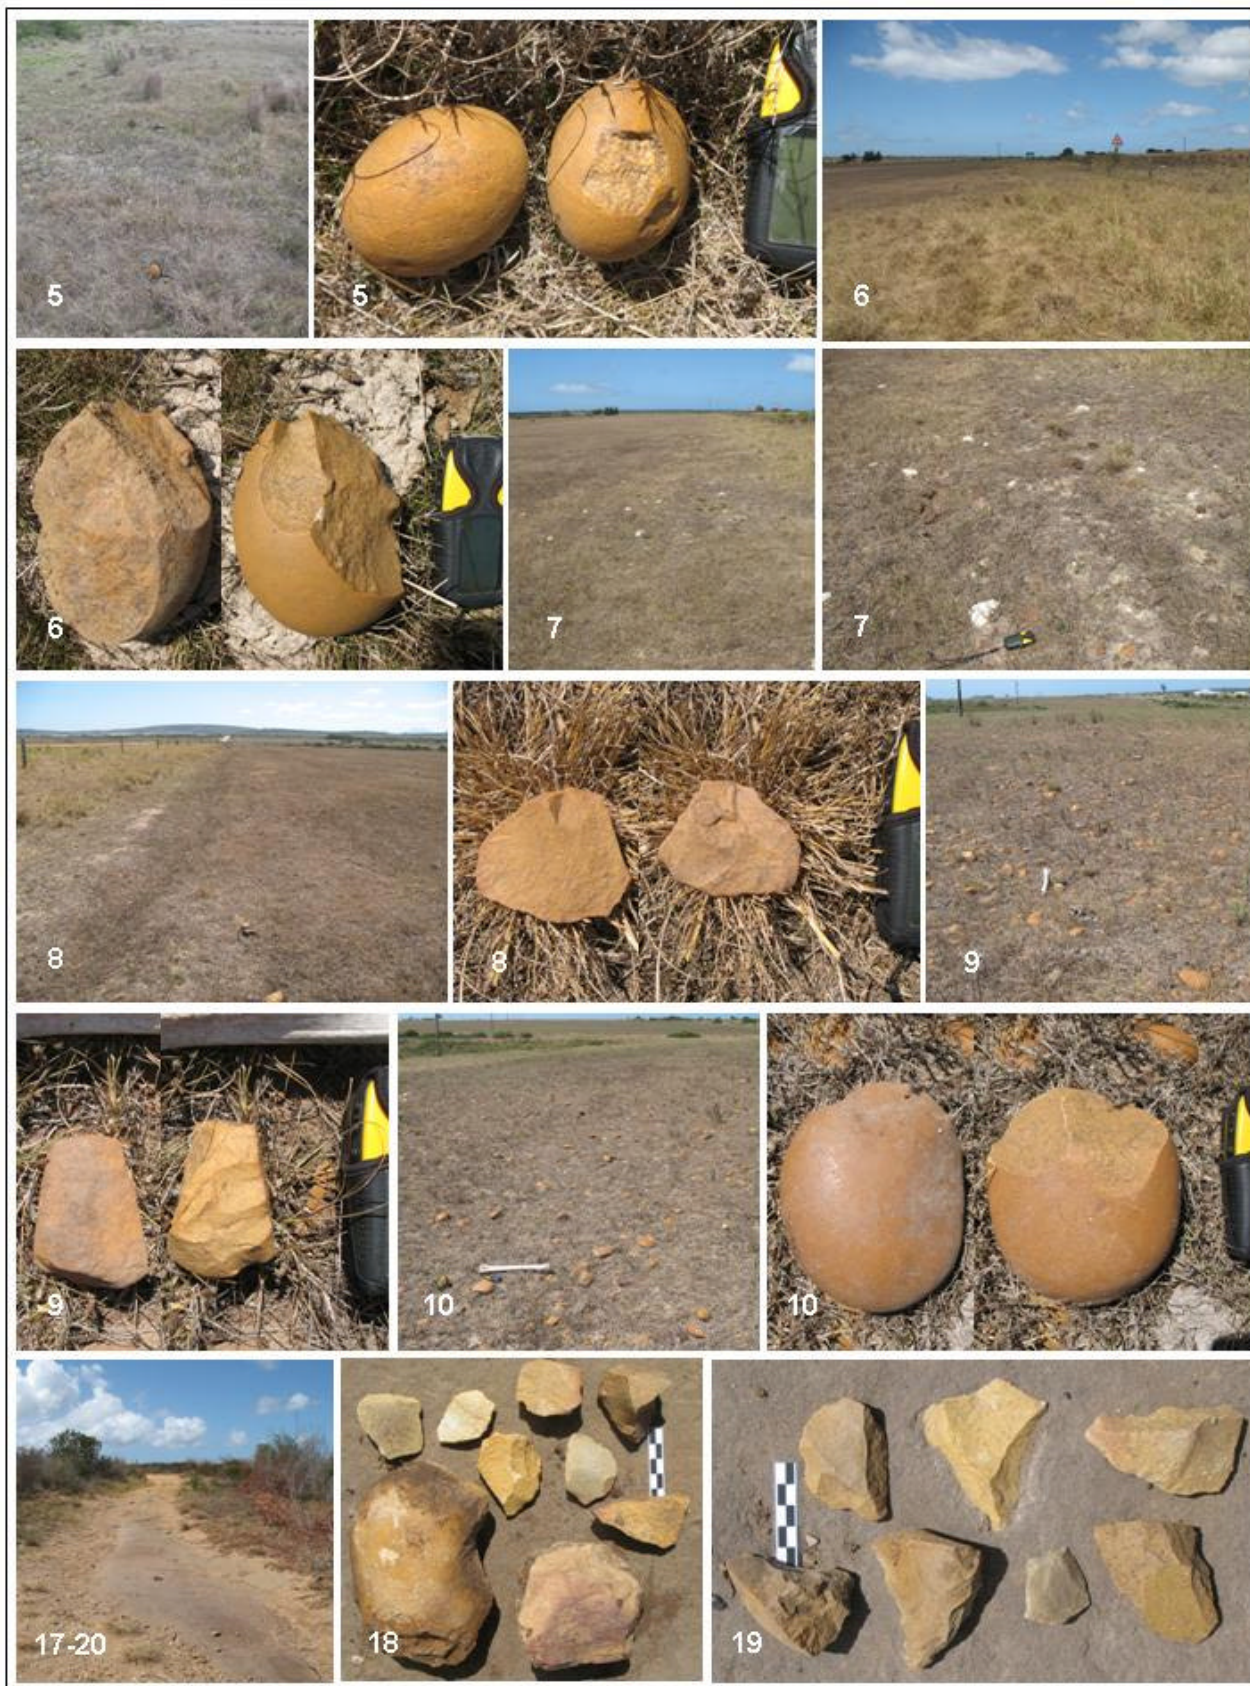
Plate 2. Like numbered images show context and close-ups of archaeological observations respectively. See Figures 5 and 6 for positions of observations and photographs. Cm scale and Garmin Camo hand held GPS as scale for the view closest to it.

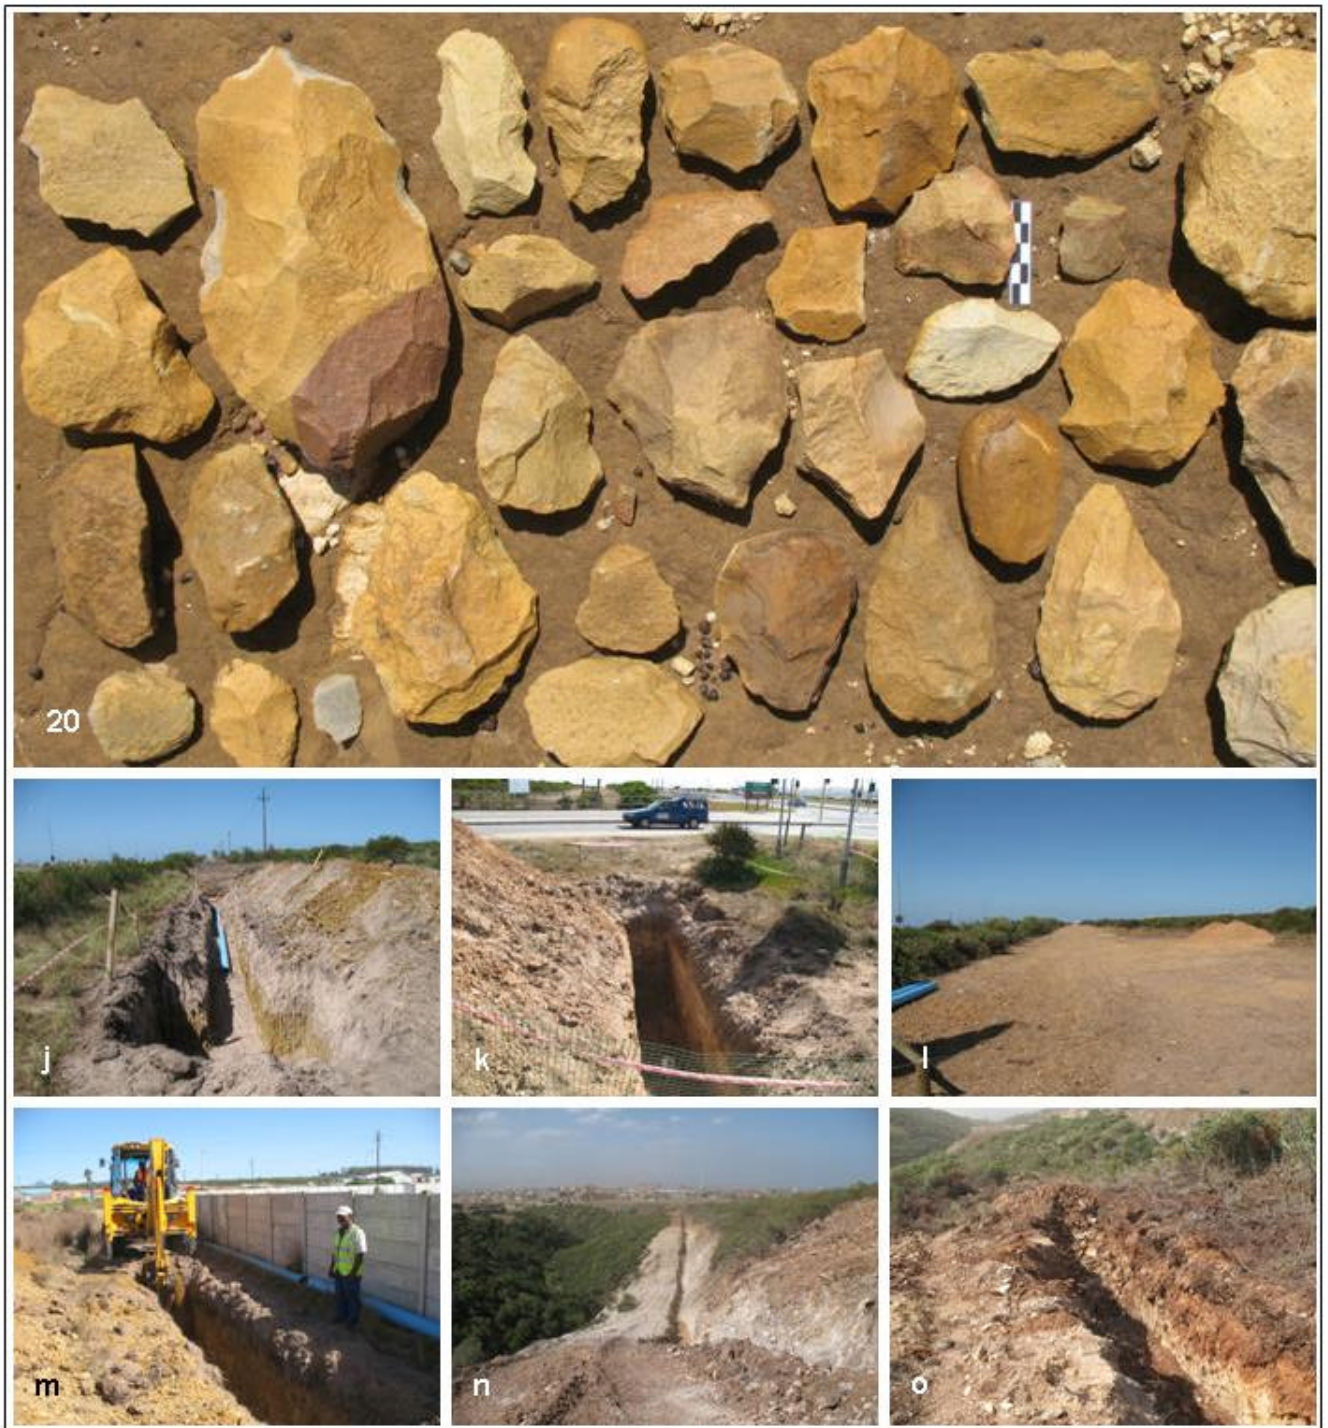
Plate 3. Image 20 shows examples of stone artefacts observed at locality 20 (cm scale - see Figure 6 for position of observation). Images j through o show examples of trenches and profiles and area cleared of vegetation. See Figures 5 and 6 for positions of observations and photographs and orientation of views. Cm scale.
