Archaeological Impact Assessment

Sedgefield Water Supply Augmentation Scheme: Erf 3517, Galjoen Road, Erf 1634, Erf 2445, Bitou Street, Oestervanger Road, Melkhout Street, Erf 3859, Erf 3858 and Erf 3518, Sedgefield, Knysna Municipality, Western Cape Province

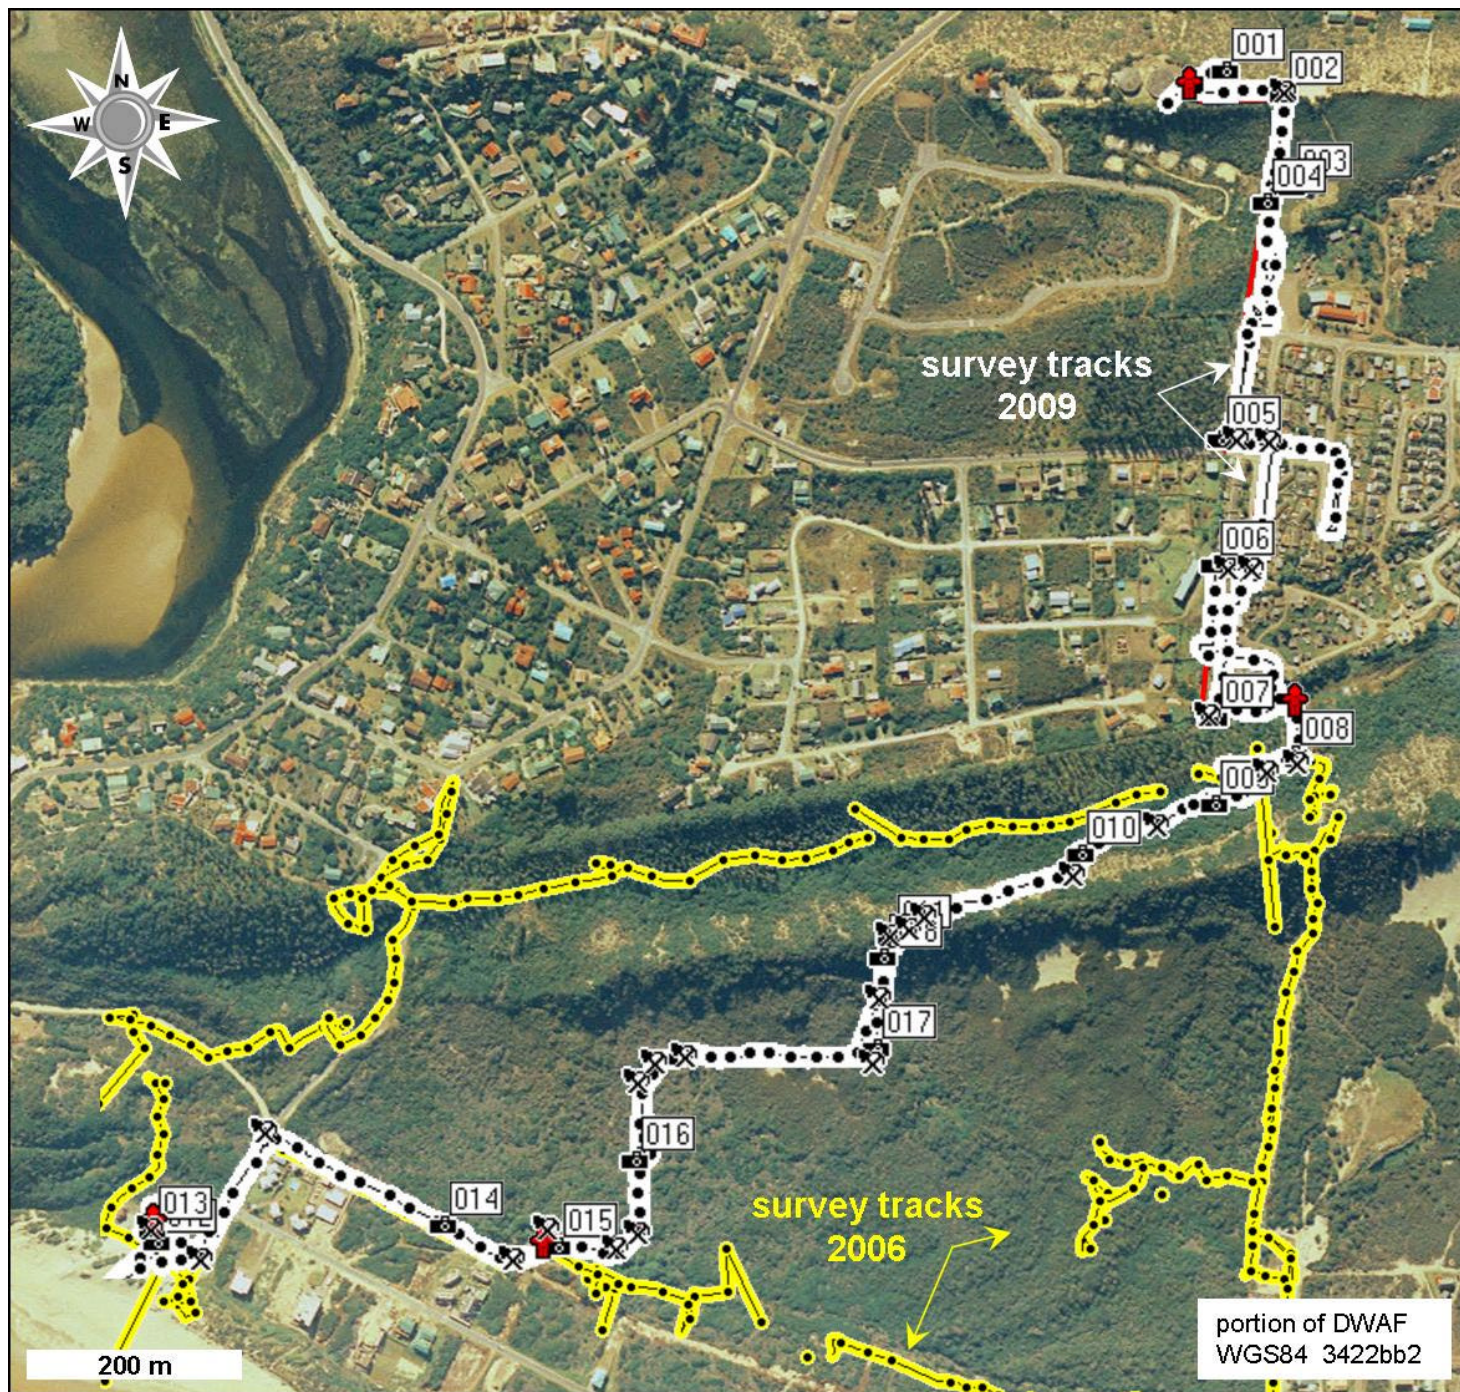
Figure 4. Enlargement of inset in Figure 2 showing the 2006 and 2009 survey tracks in yellow and white respectively. Camera icons represent photo localities and are numbered 1 through 18 in Table 1 (not 001 to 018 as above). Red fire hydrants represent structural features along pipeline route while shovel and pick axe icons represent points along the pipeline (named A to AC in Table 1). Aerial photo courtesy Surveys and Mapping

Survey tracks were fixed with a hand held Garmin Camo GPS to record the search area (Figure 4, gpx tracking file submitted to HWC and is available from author). Observations and photo localities were also fixed by GPS (Figure 4, Plates 1 through 4 and Table 1). Digital audio notes and a high quality, comprehensive digital photographic record were also made (full data set available from author).

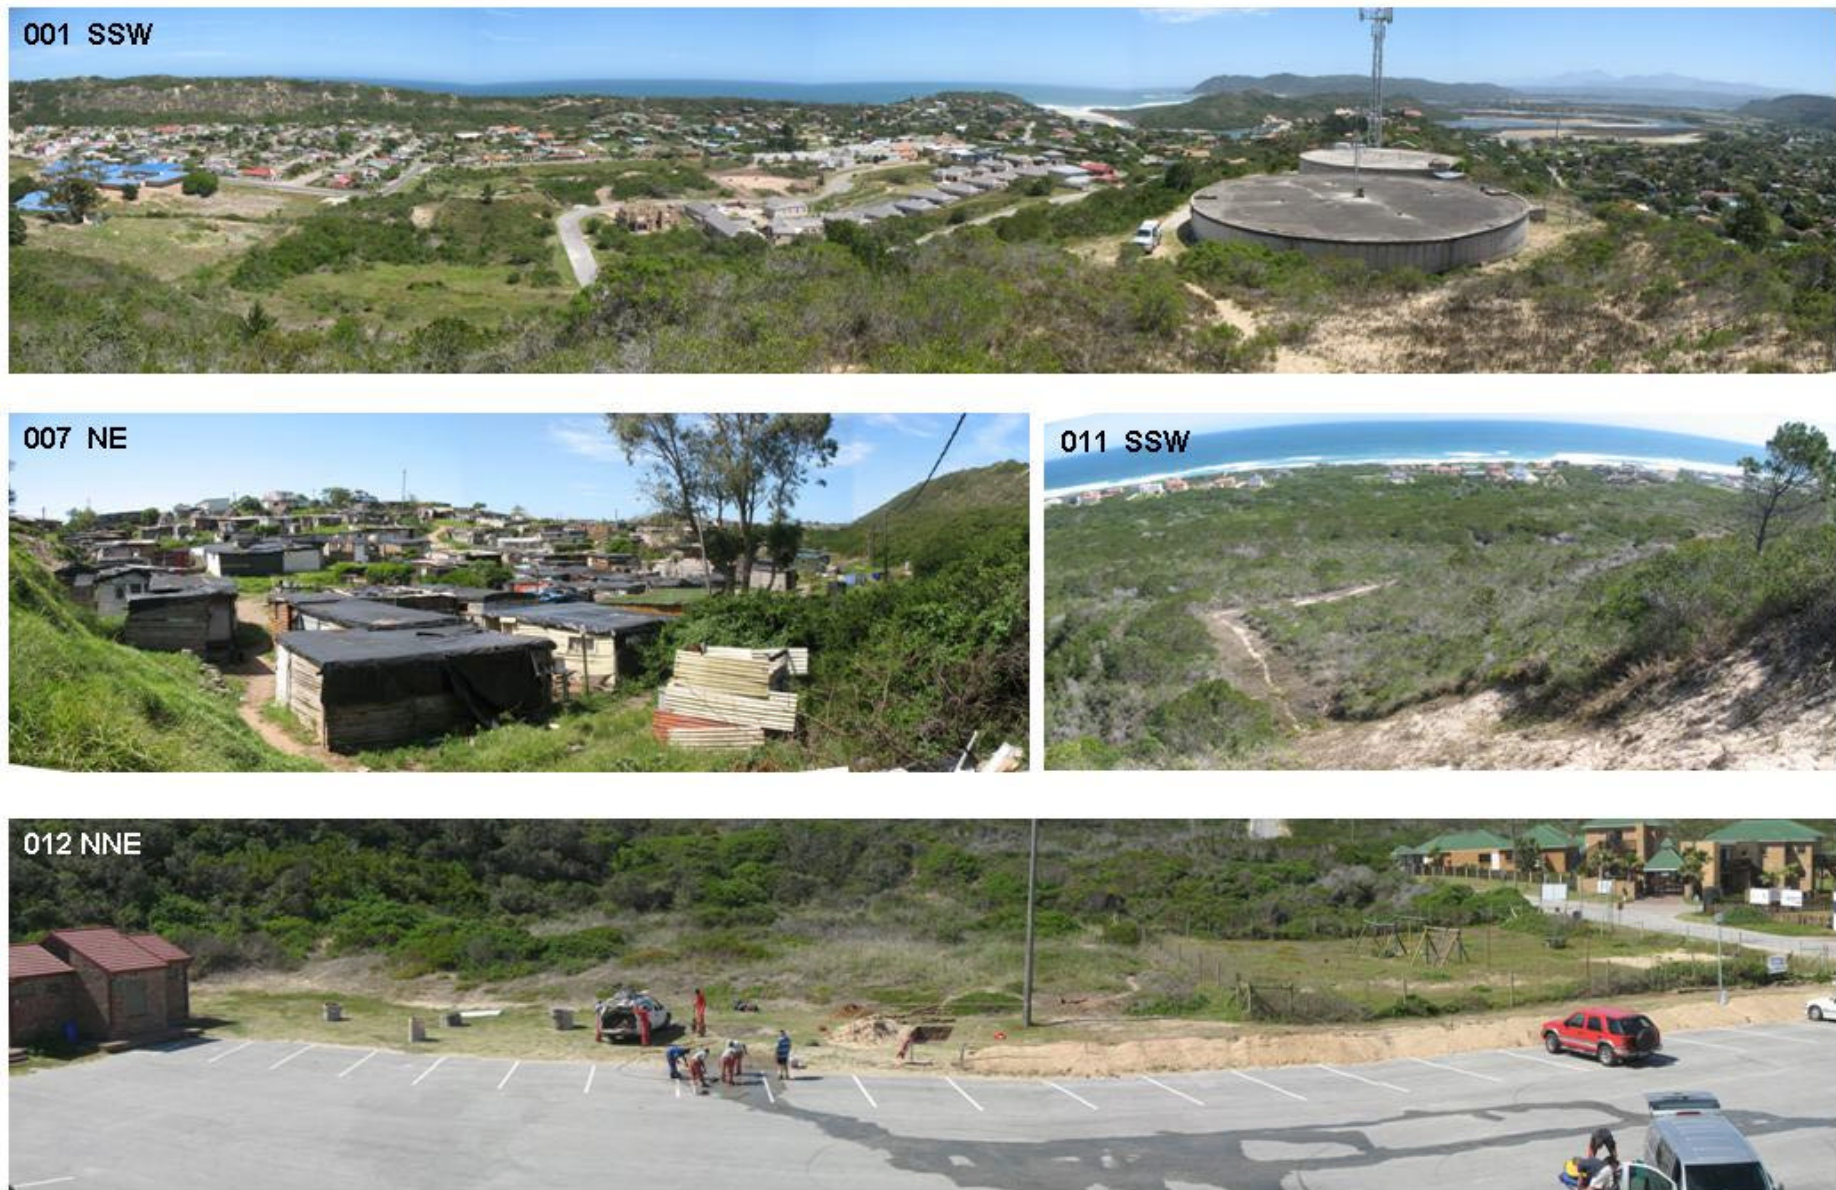
Plate 1. Panoramas - study area & features discussed in text. See locality of images in Figure 4. Letters indicate direction of view.

The immediate environment – development, vegetation, topography and so on - bordering the proposed development is varied and examples are shown in Plates 1 through 4. The localities of photographs are established by matching the numbers on photographs with those of waypoints in Figure 4. The images show that most of the northern route runs through previously developed areas while the southern portion is dominated by undeveloped land except for the existing sewer line next to which the proposed pipeline will be installed. In undeveloped areas, vegetation has been cleared along the pipeline route in a tract of around 5 to 8m wide (Plates 1 through 4).

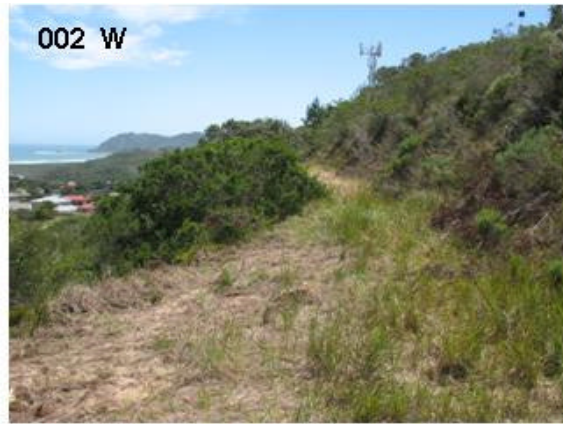
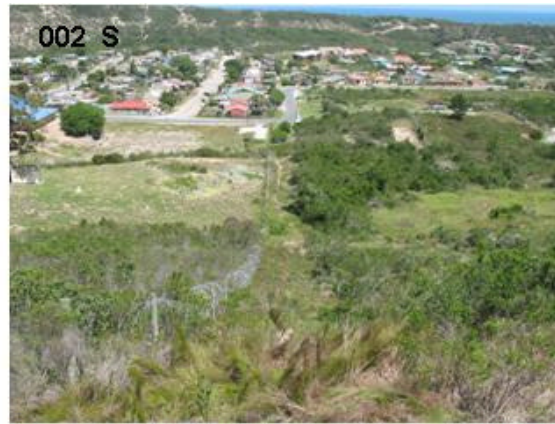
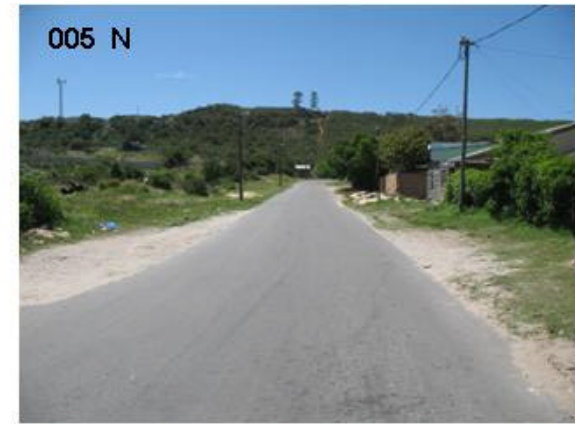
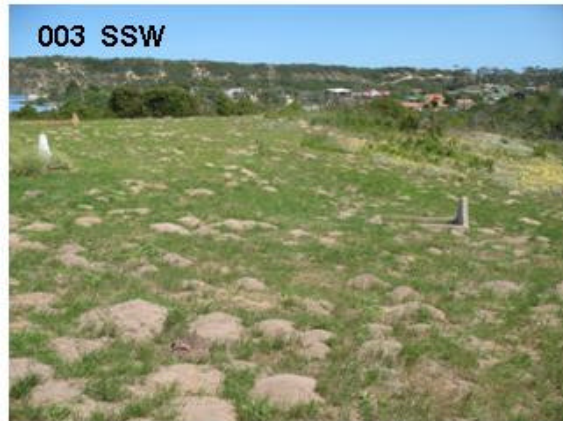
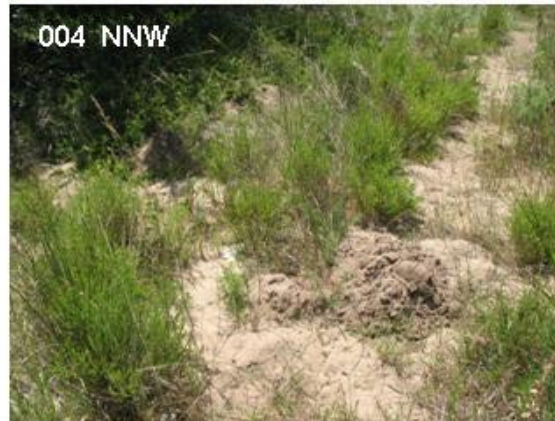
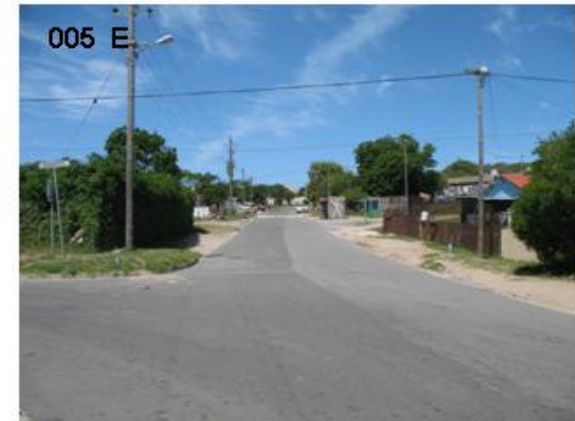
Plate 2. Views of various sections along the pipeline route. See locality of images in Figure 4. Letters indicate direction of view.

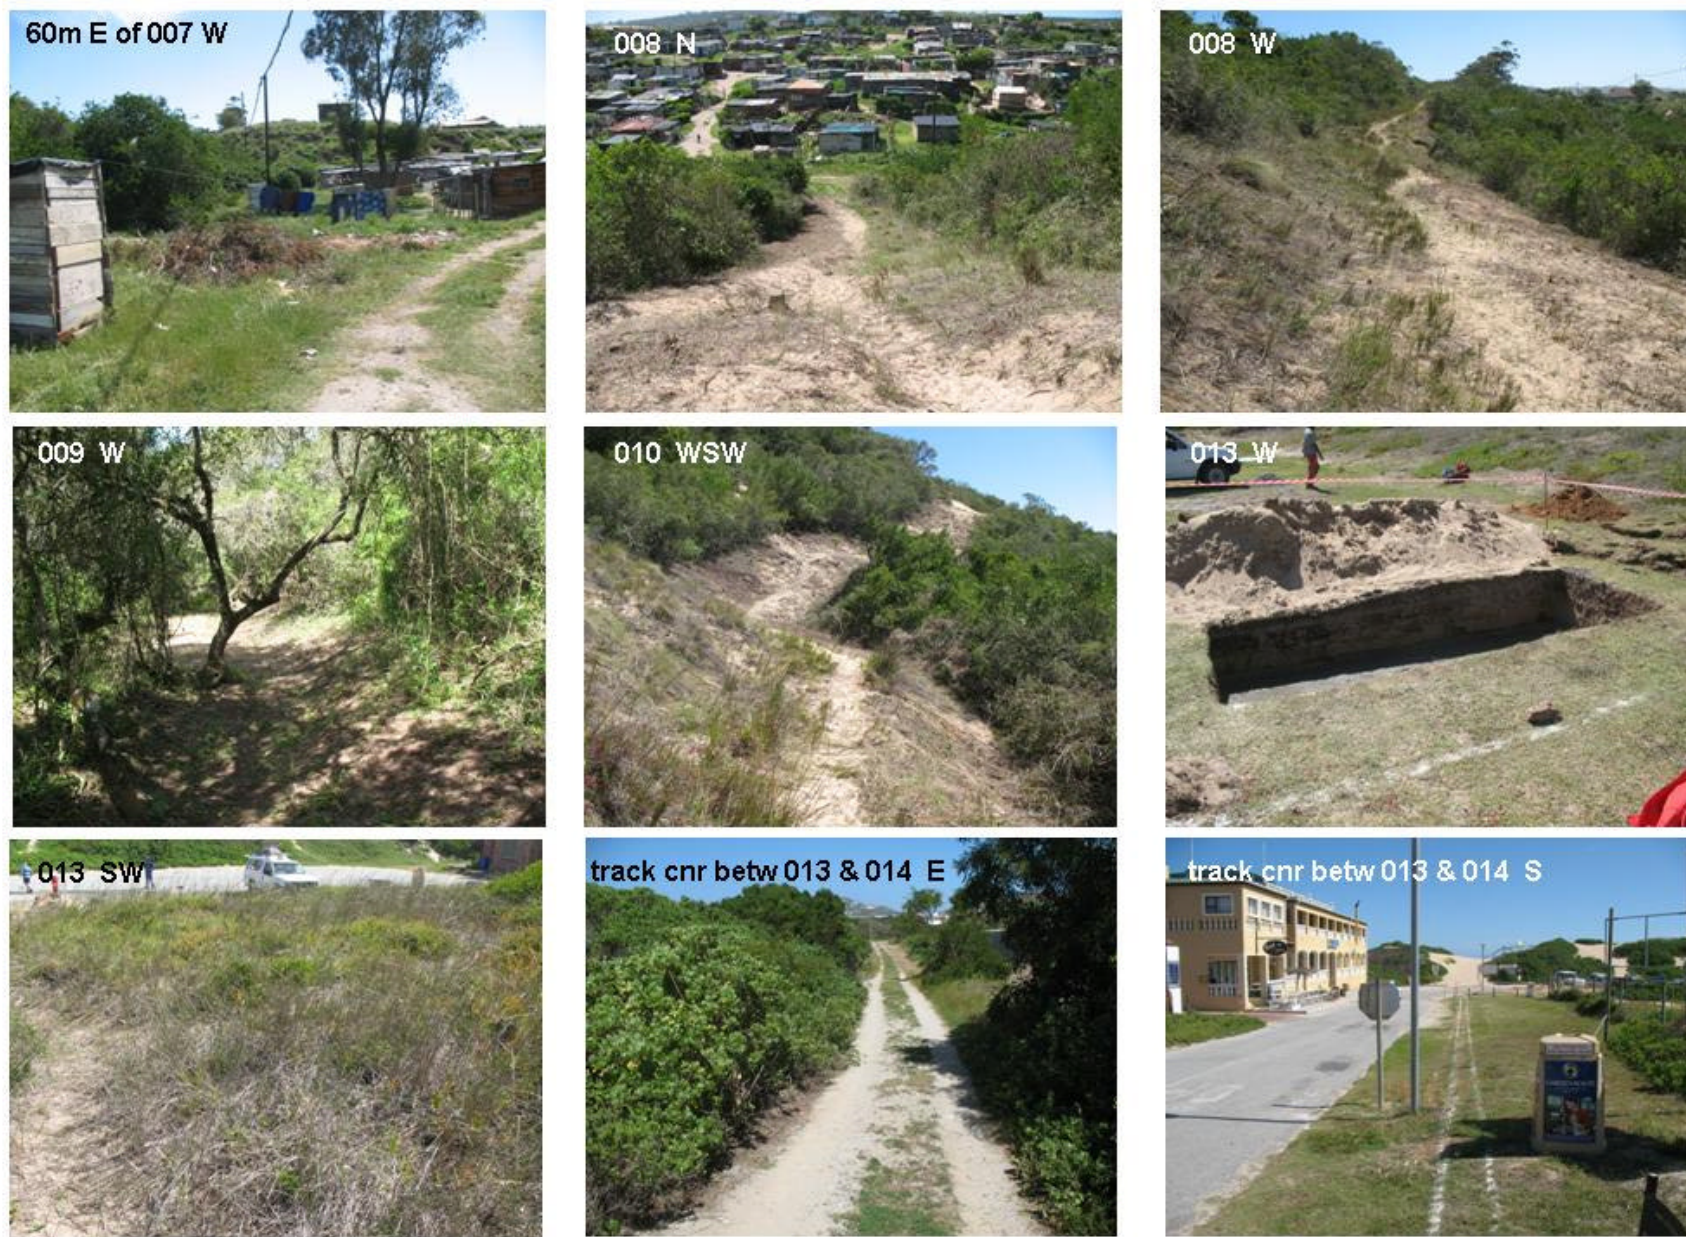
Plate 3. Views of various sections along the pipeline route. See locality of images in Figure 4. Letters indicate direction of view.

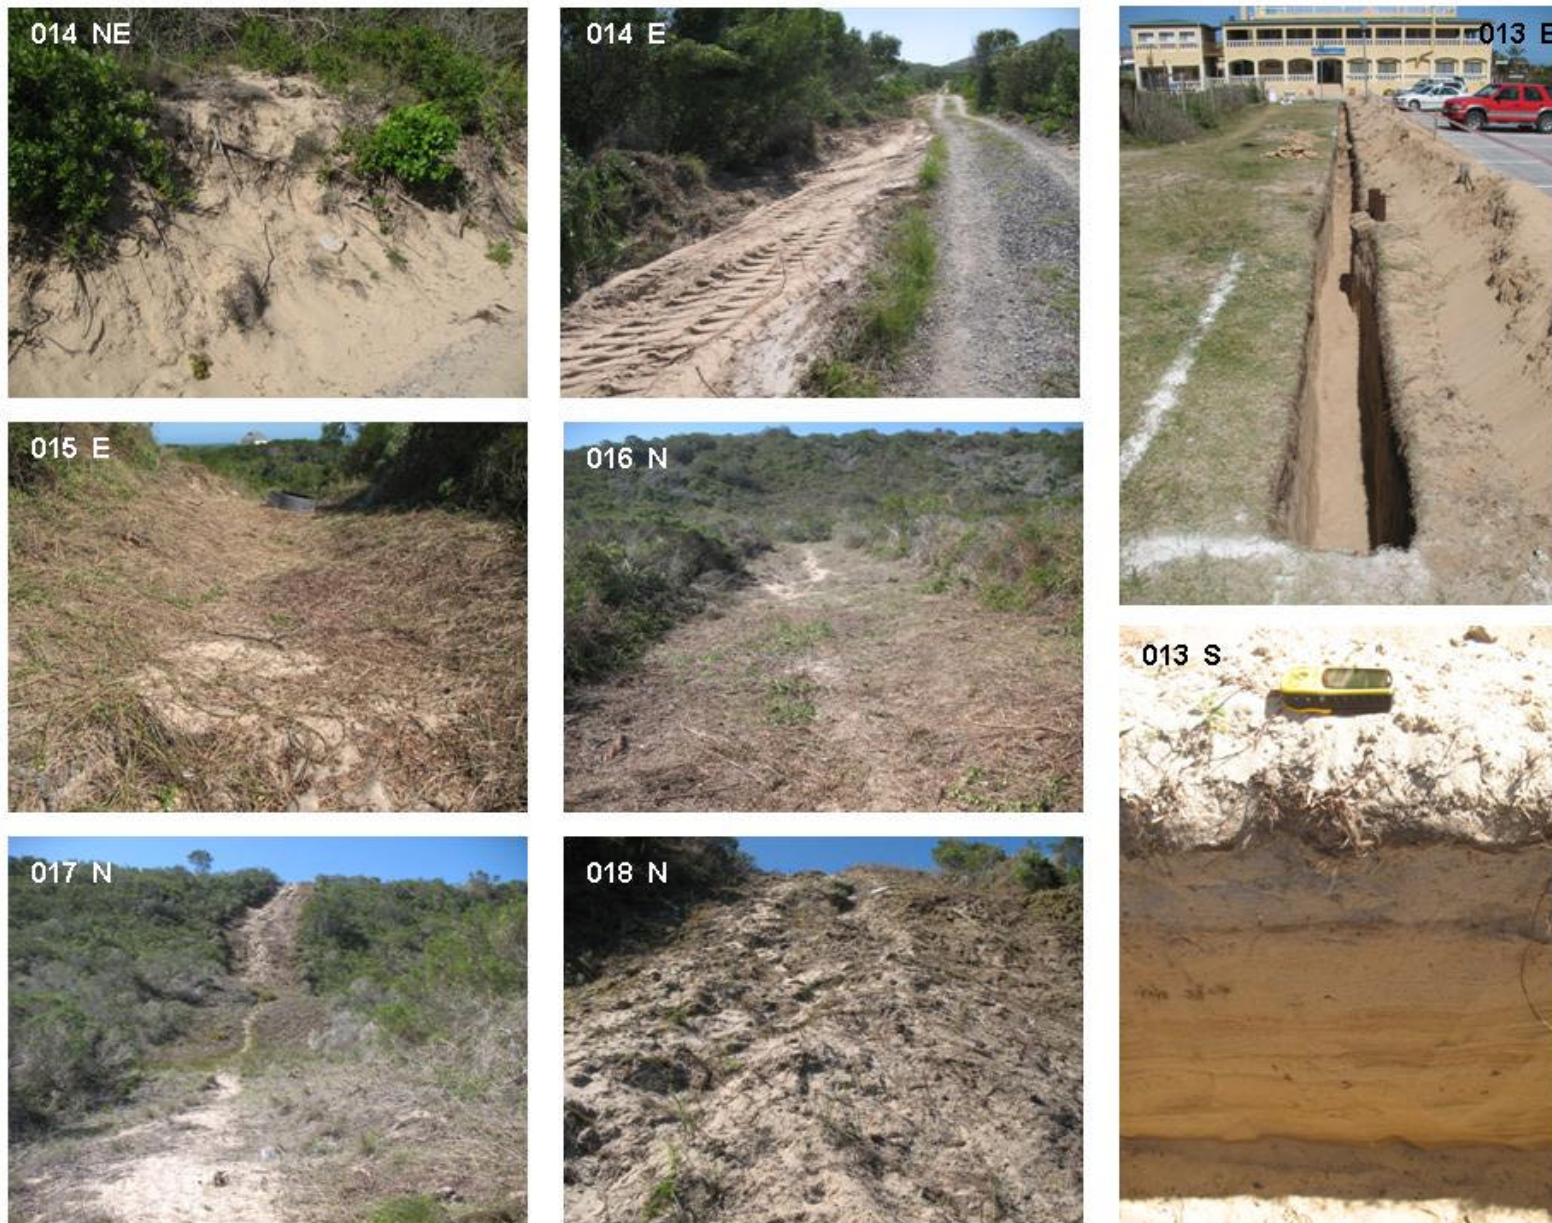
Plate 4. Views of various sections along the pipeline route. 013 shows an excavated trench and a part of its exposed profile of sterile aeolian sand. See locality of images in Figure 4. Letters indicate direction of view.

In approximately 2.5 hours of survey a distance of 6.5km was traversed, covering an area of about 2.6ha, of which – in undeveloped areas - an average of around 70% provided good archaeological visibility (Figure 4 and Plates 1 through 4). No archaeological materials were identified during the study. Neither mole heaps nor previous human disturbances revealed a trace of subsurface archaeological material. A recently excavated trench adjacent to the car park at Myoli beach showed a profile of sterile dune sand (Plate 4 – 013).
