Archaeological Impact Assessment

Proposed refurbishment of the Ernest Robertson Pipeline, Great Brak River, Mossel Bay Municipality, Mossel Bay, Western Cape Province

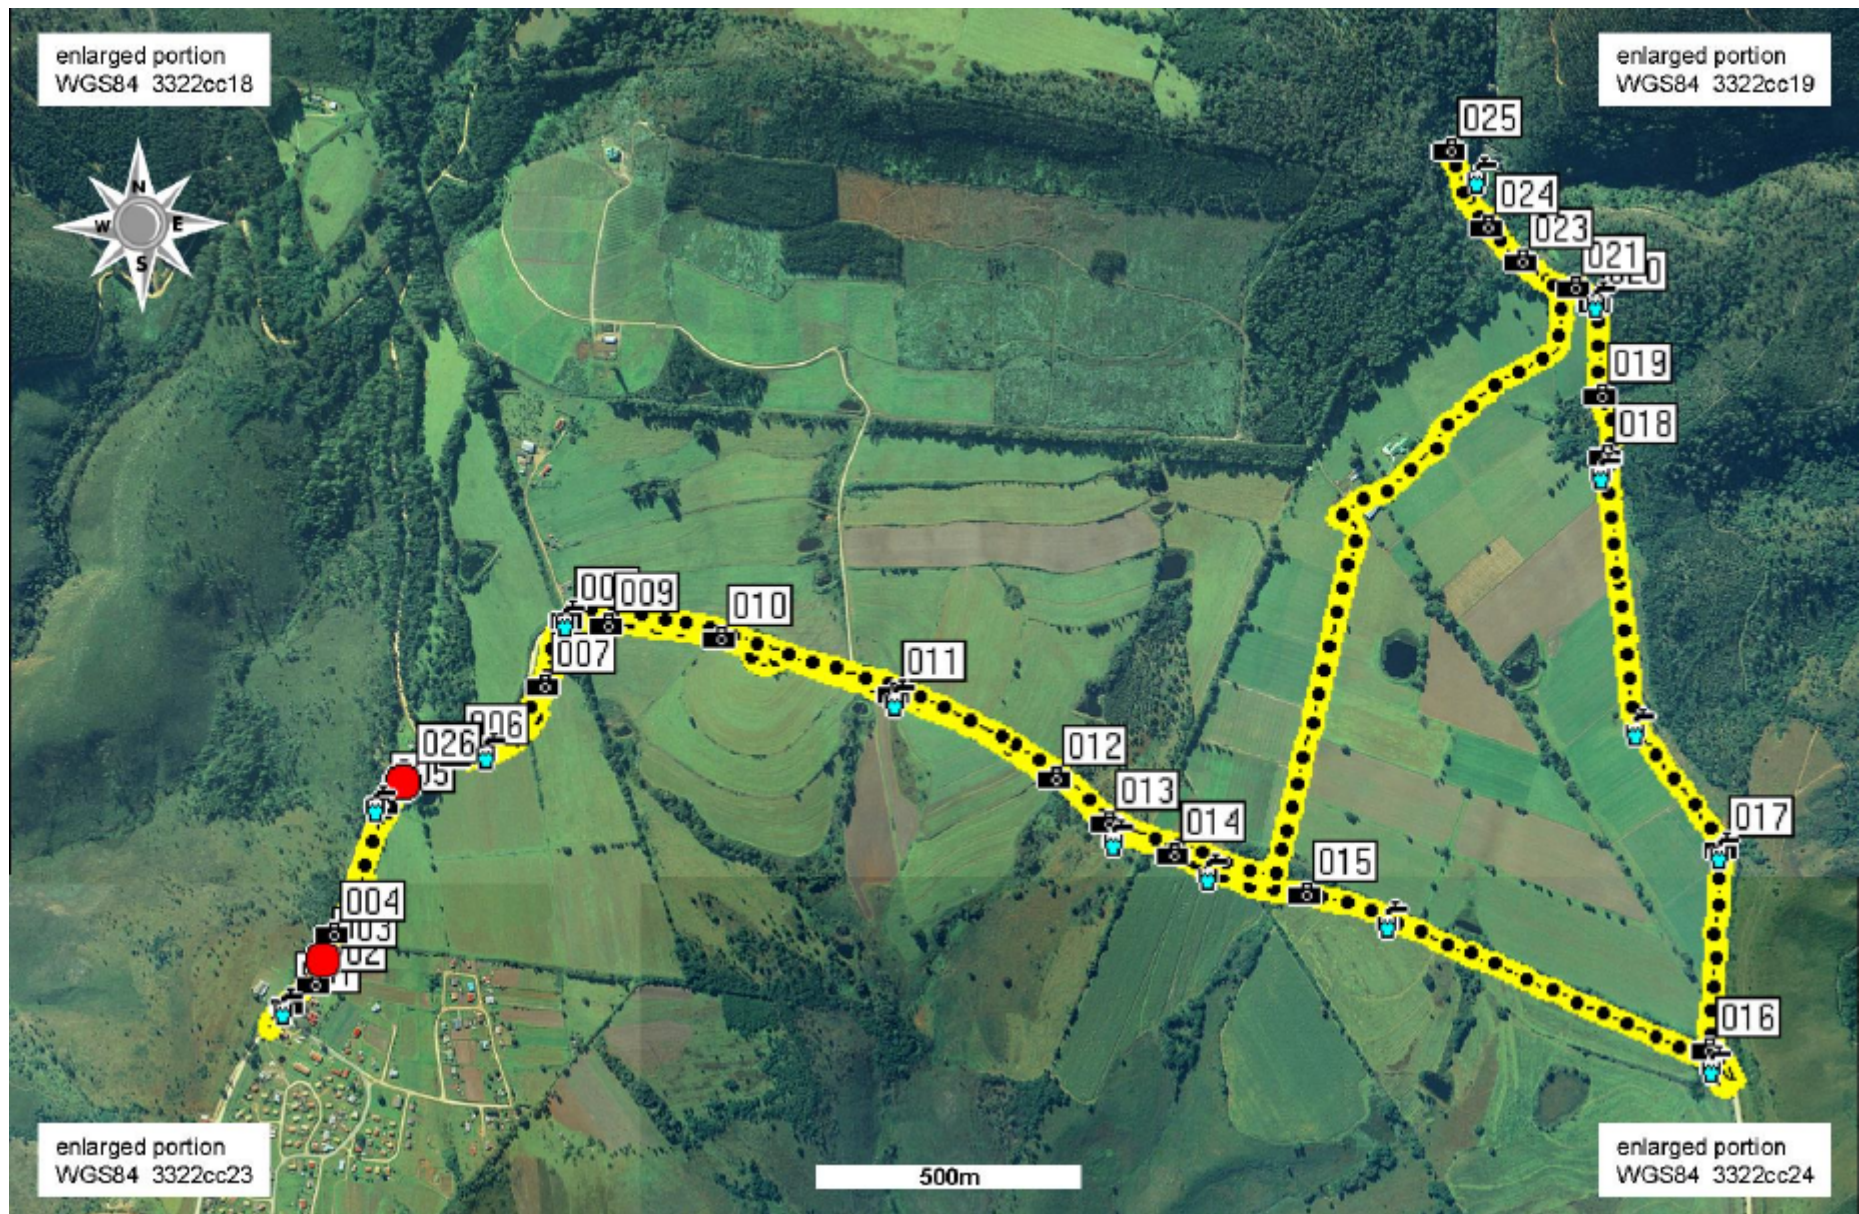
Figure 3. Enlarged area indicated in Fig. 1 with walk tracks (yellow), photo and observation points (red) (Tables 1 & 2). Courtesy Surveys & Mapping.

Survey tracks were fixed with a hand held Garmin Camo GPS to record the search area (Figures 3 & 5, gpx tracking file submitted to HWC and is available from author). Observations and photo localities were also fixed by GPS (Figures 3 & 5, Plates 1 through 6 and Table 2). Digital audio notes and a high quality, comprehensive digital photographic record were also made (full data set available from author). Localities of photographs are established by matching the numbers on photographs with those of waypoints in Figures 3 & 5. Directions of views are indicated with compass bearing names like E is east; WSW is west south west, and so on. The walk track directly from waypoint 21 and ending between waypoints 14 and 15 is a return track and not part of the survey (Figure 2).

2.1 Waypoint 2 - snd6637, img6636-7 (Figure 3, Plate 5 and Table 2)

2.2 Waypoint 26 - snd6687, img6679-87 (Figure 3, Plates 5 & 6 and Table 2)

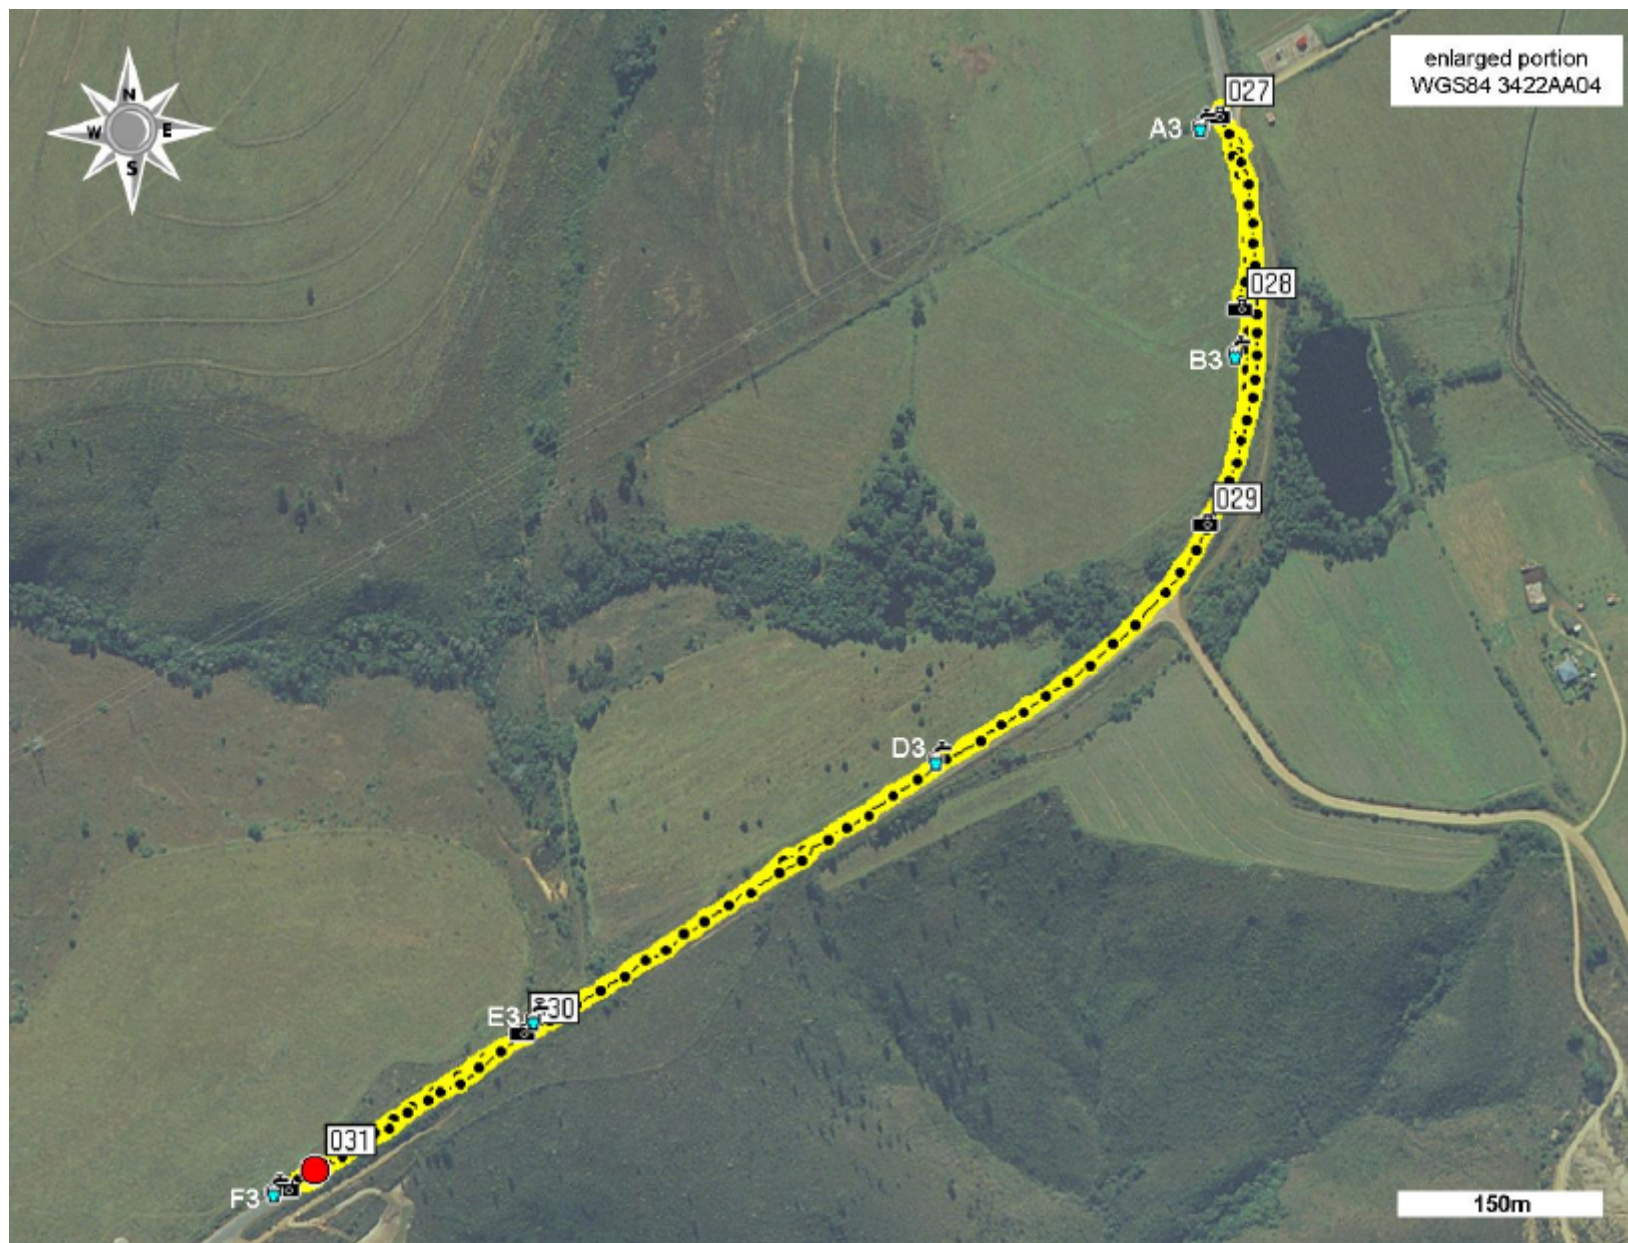
Figure 5. Enlarged area as indicated in Figure 4 with walk track (yellow), photo & observation points (red) and route points (Tables 1 & 2).

2.3 Waypoint 31 - snd6699, img corrupt (Figure 5 and Table 2)

Archaeological material occurs on the edge of and in association with materials excavated from a trench and is therefore in a disturbed context. The trench is within the road reserve and adjacent to a game fence. One small hand axe, potentially of the Fauresmith or early Middle Stone Age period, a disc core and a flake of MSA origin were recorded. Other artefacts are likely to occur along the trenched area. Photographs were corrupted.

Significance & Recommendation: These finds are in a disturbed context and therefore considered of low significance. No further research or measures in mitigation are required.

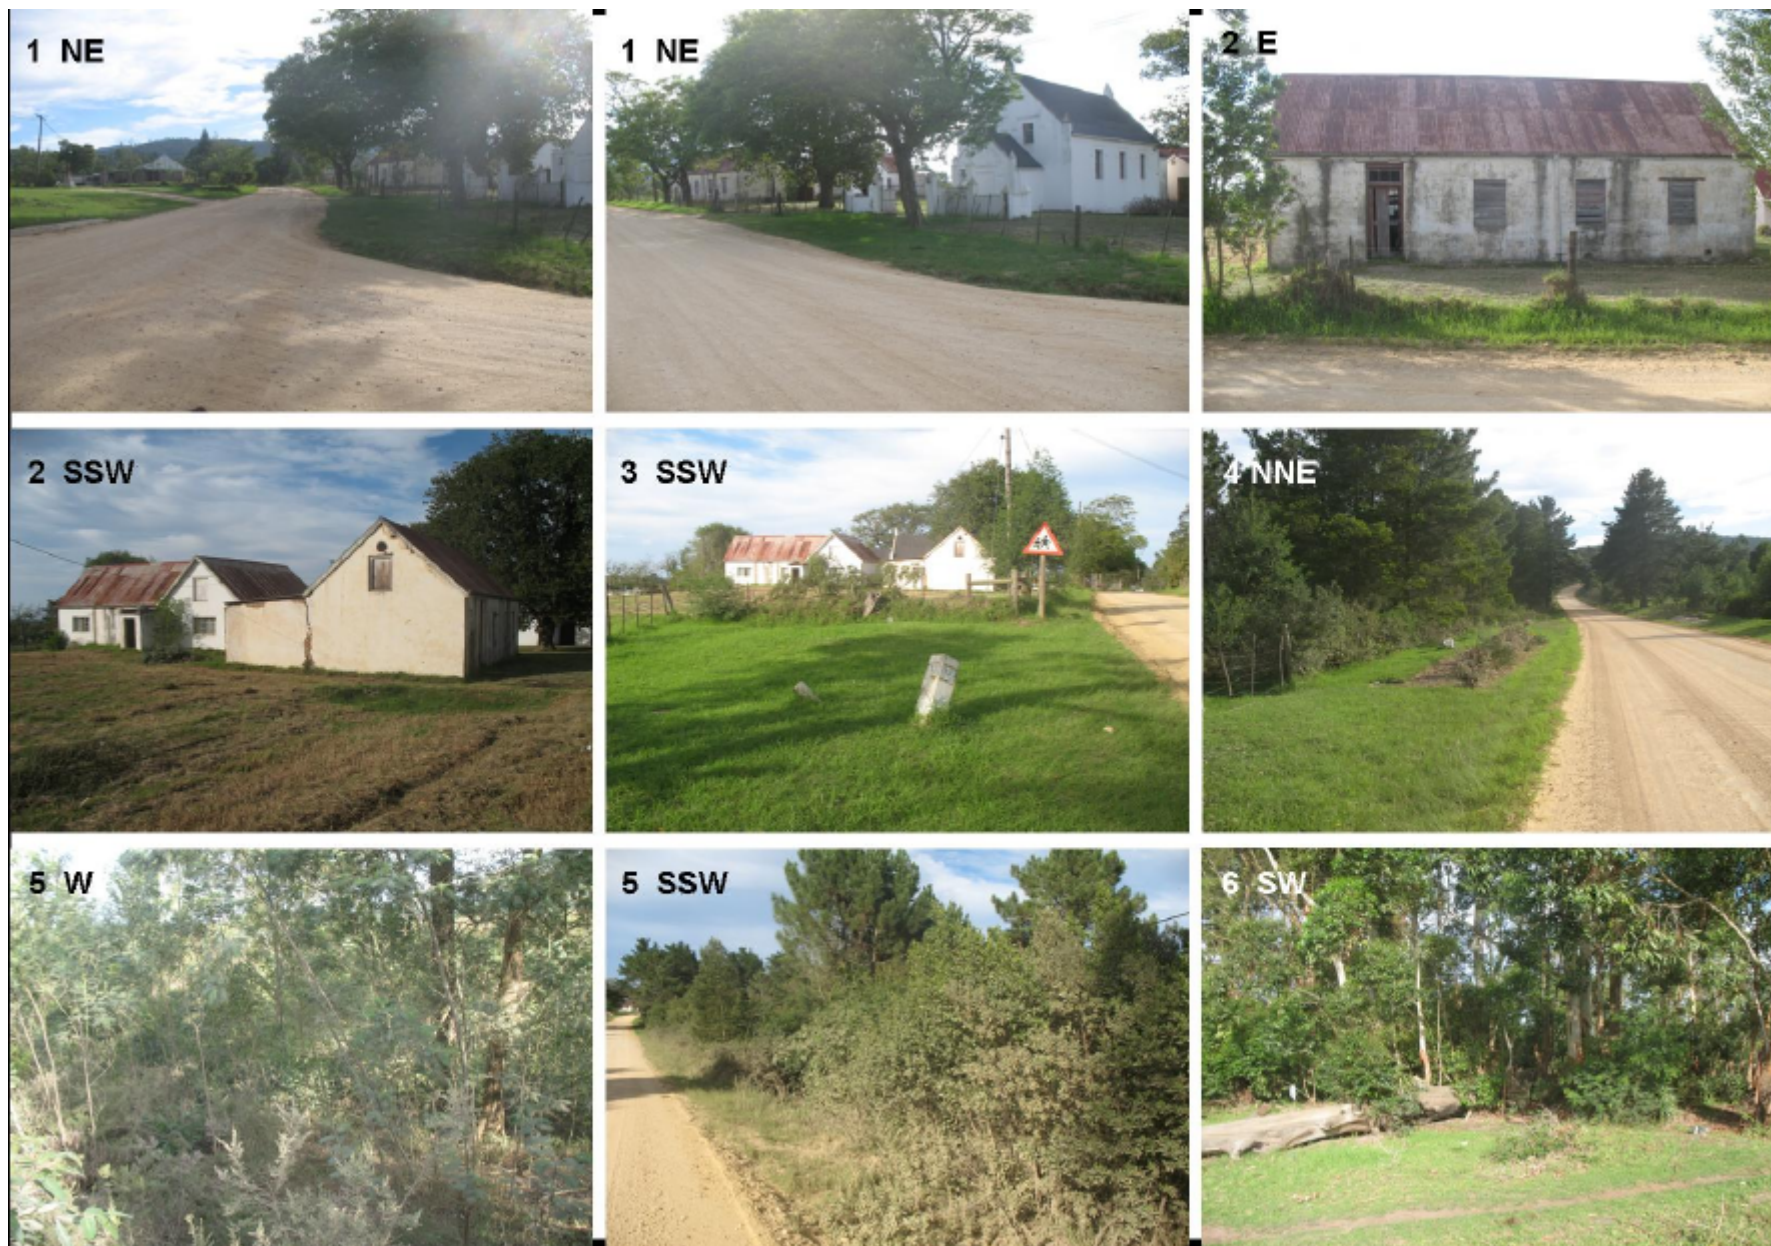
Plate 1. Examples of the surrounding environment, topography and vegetation cover. Old houses at Friemersheim.

These are two houses that are certainly older than 60 years, but lie well beyond the proposed pipeline route and will in no way be impacted by it.

Significance & Recommendation: Though these heritage resources are significant, they will not be impacted by the proposed activity, and no further research or measures in mitigation are required.

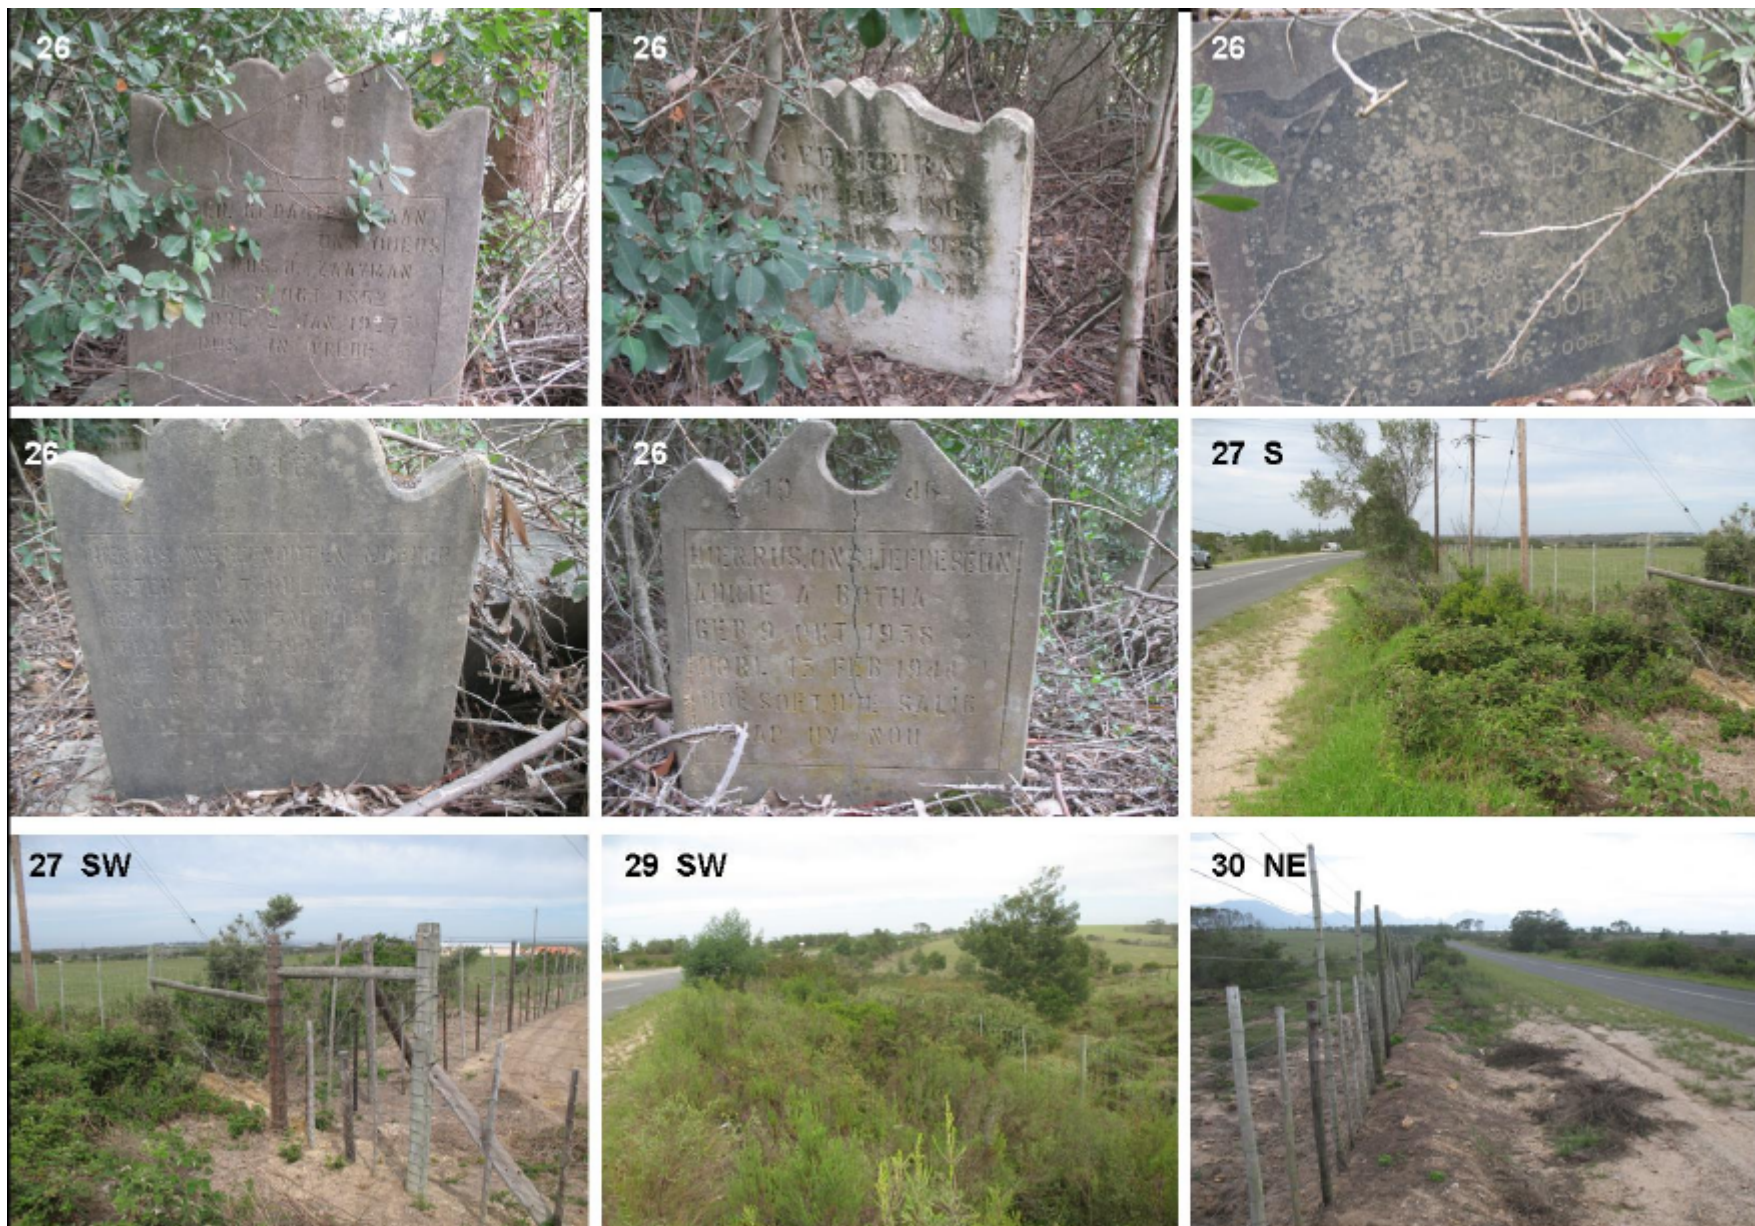
Plate 6. Waypoint 26 – cemetery. Examples of the surrounding environment, topography and vegetation cover.

This is a small fenced graveyard immediately SE of the gravel road that runs through Friemersheim. Overall the graveyard is in a disused state with broken and dilapidated fences, broken and fallen headstones and the graves are overgrown with vegetation. The extent of the fenced area is about 100m² and 8 graves were counted, but more may be obscured by vegetation growth over most of the cemetery. All graves are E-W aligned. One grave is large and can potentially contain the remains of three individuals. Dates on most of

the graves are around 1945, but some are dated to 1927 and 1938. Photographs were taken of individual head stones showing their designs and inscriptions, and the photographs are available on request. One or two head stones are in marble and the rest are in concrete. Four of the concrete head stones are of identical design. No other, associated cultural remains were identified, though materials may be covered by vegetation and/or leaf litter.

Significance & Recommendation: The cemetery is considered of high significance and the pipeline route – if not already adjusted - must be aligned so that it skirts the fenced area of the cemetery.

- The small cemetery must be avoided during the installation of this portion of the pipeline.
