Archaeological Impact Assessment
with comment on Palaeontology by Dr John Almond

**Proposed Enlargement and Remedial Work on Platrug Dam, Portion
40 of Farm 208, George, Eden, Western Province**

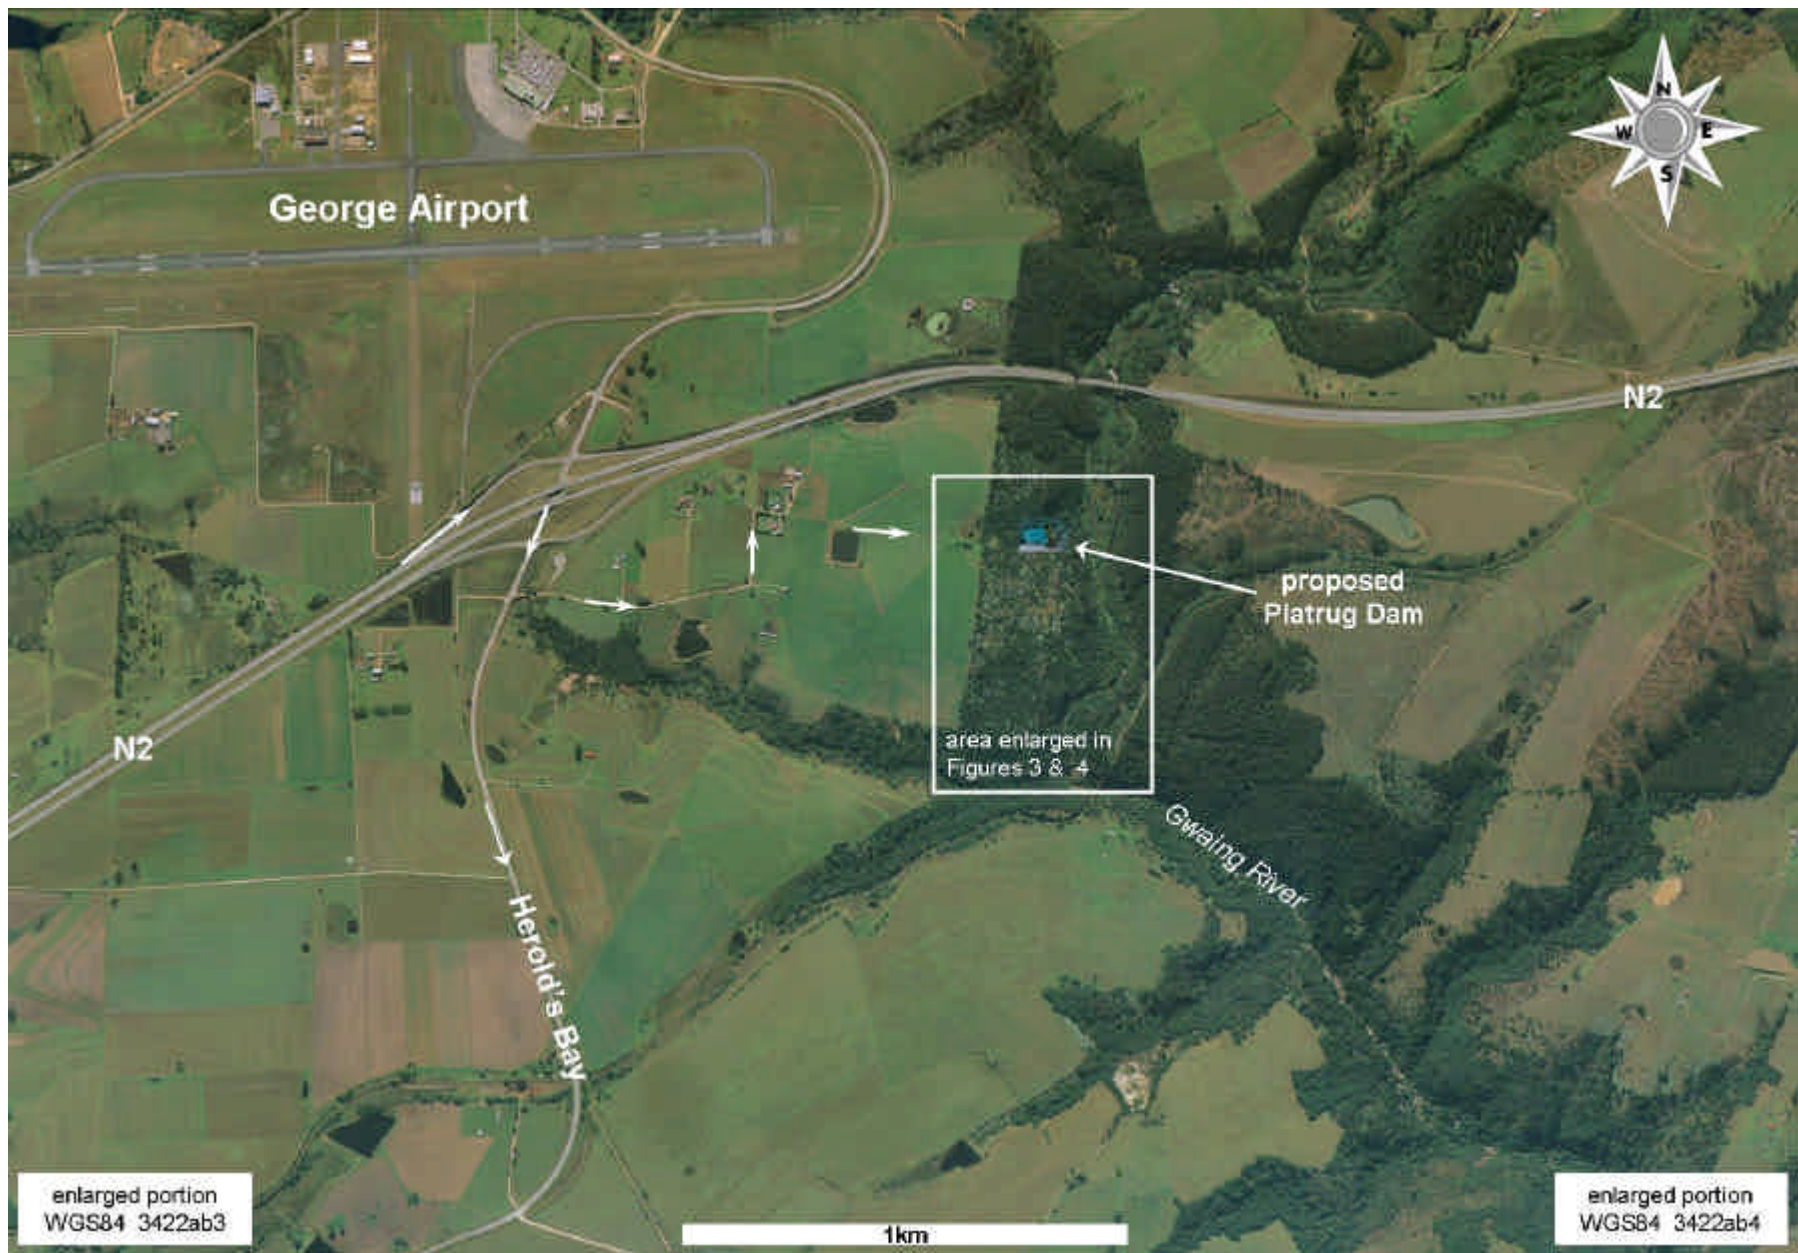
Figure 2. Enlarged area as indicated in Figure 1 showing study area and access route (Aerial photos courtesy of CDSM).

Portion 40 of Farm 208 is approximately 24ha in extent and is situated south of the N2, SE of the George Airport and George lies to the NE (Figure 1). The R102 leading to Herold's Bay lies to the west of the property (Figures 1 & 2). The Gwaing River and a tributary thereof are situated immediately east and south of the property respectively (Figure 2). Travelling from Mossel Bay along the N2, the property was accessed by vehicle by taking the George Airport/Herold's Bay exit, by turning right onto the R102 at the end of the off ramp and then by turning left onto a gravel road which leads to the study area (see directional arrows in Figure 2).

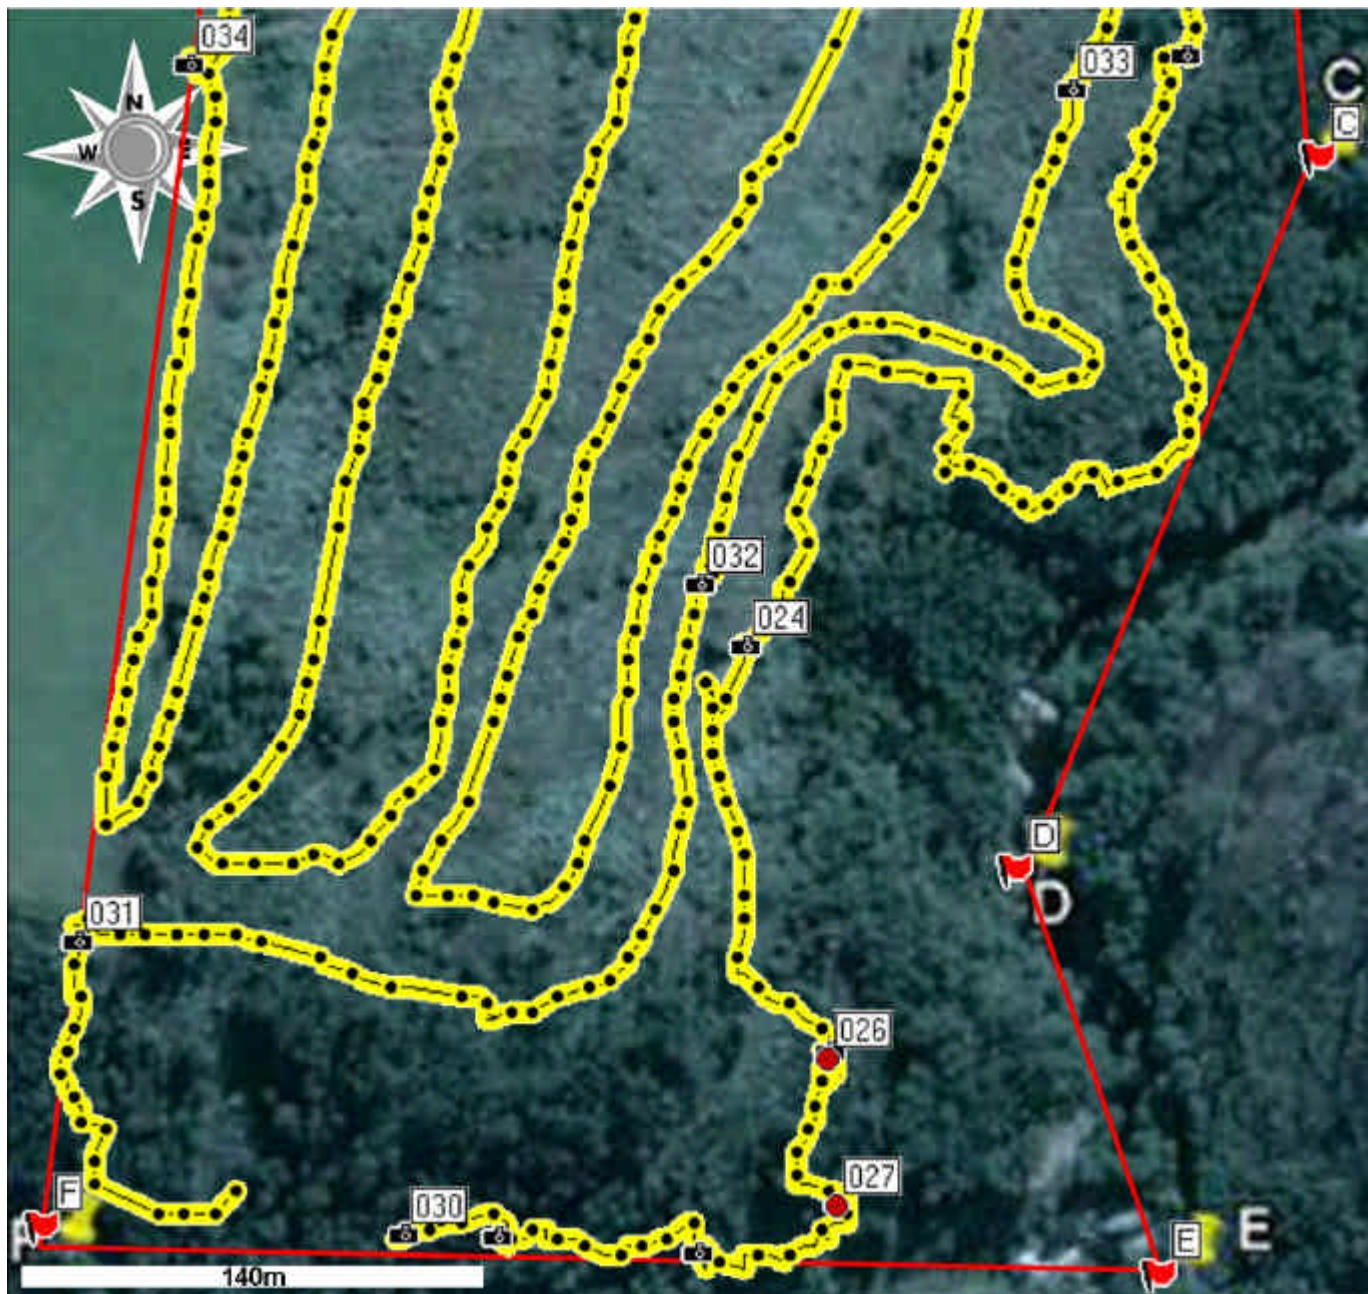
Figure 6. Enlarged area as indicated in Figure 4 showing walk tracks and waypoints of archaeological occurrences and photo localities (Aerial photos courtesy Google Earth). See Tables 1 and 2 for coordinate data and Plates 1 to 6.

Survey tracks were fixed with a hand held Garmin Camo GPS to record the search area (Figures 4, 5 & 6) and a gpx tracking file was submitted to HWC and is available from the author. The positions of archaeological occurrences and photo localities were fixed by GPS (Figures 5 & 6, Plates 1 through 6 and Table 2). Digital audio notes and a comprehensive, high quality digital photographic record were also made (full data set available from author). In this report, localities of archaeological occurrences and photographs are established by matching the numbers on photographs with those of waypoints in Figures 5 & 6 (details in Table 2). Directions of views are indicated with compass bearing names like E is east; WSW is west south west, and so on. Bearing names on panoramic views indicate the bearing at the position of the label on the photograph (Plates 1 through 3).

On 21 June 2010 - in about 3.5 hours of survey - a distance of 7.5km was walked, covering an area of about 5ha of which an average of about 20% provided archaeological visibility (Figures 5 & 6 and Plates 1 through 6).

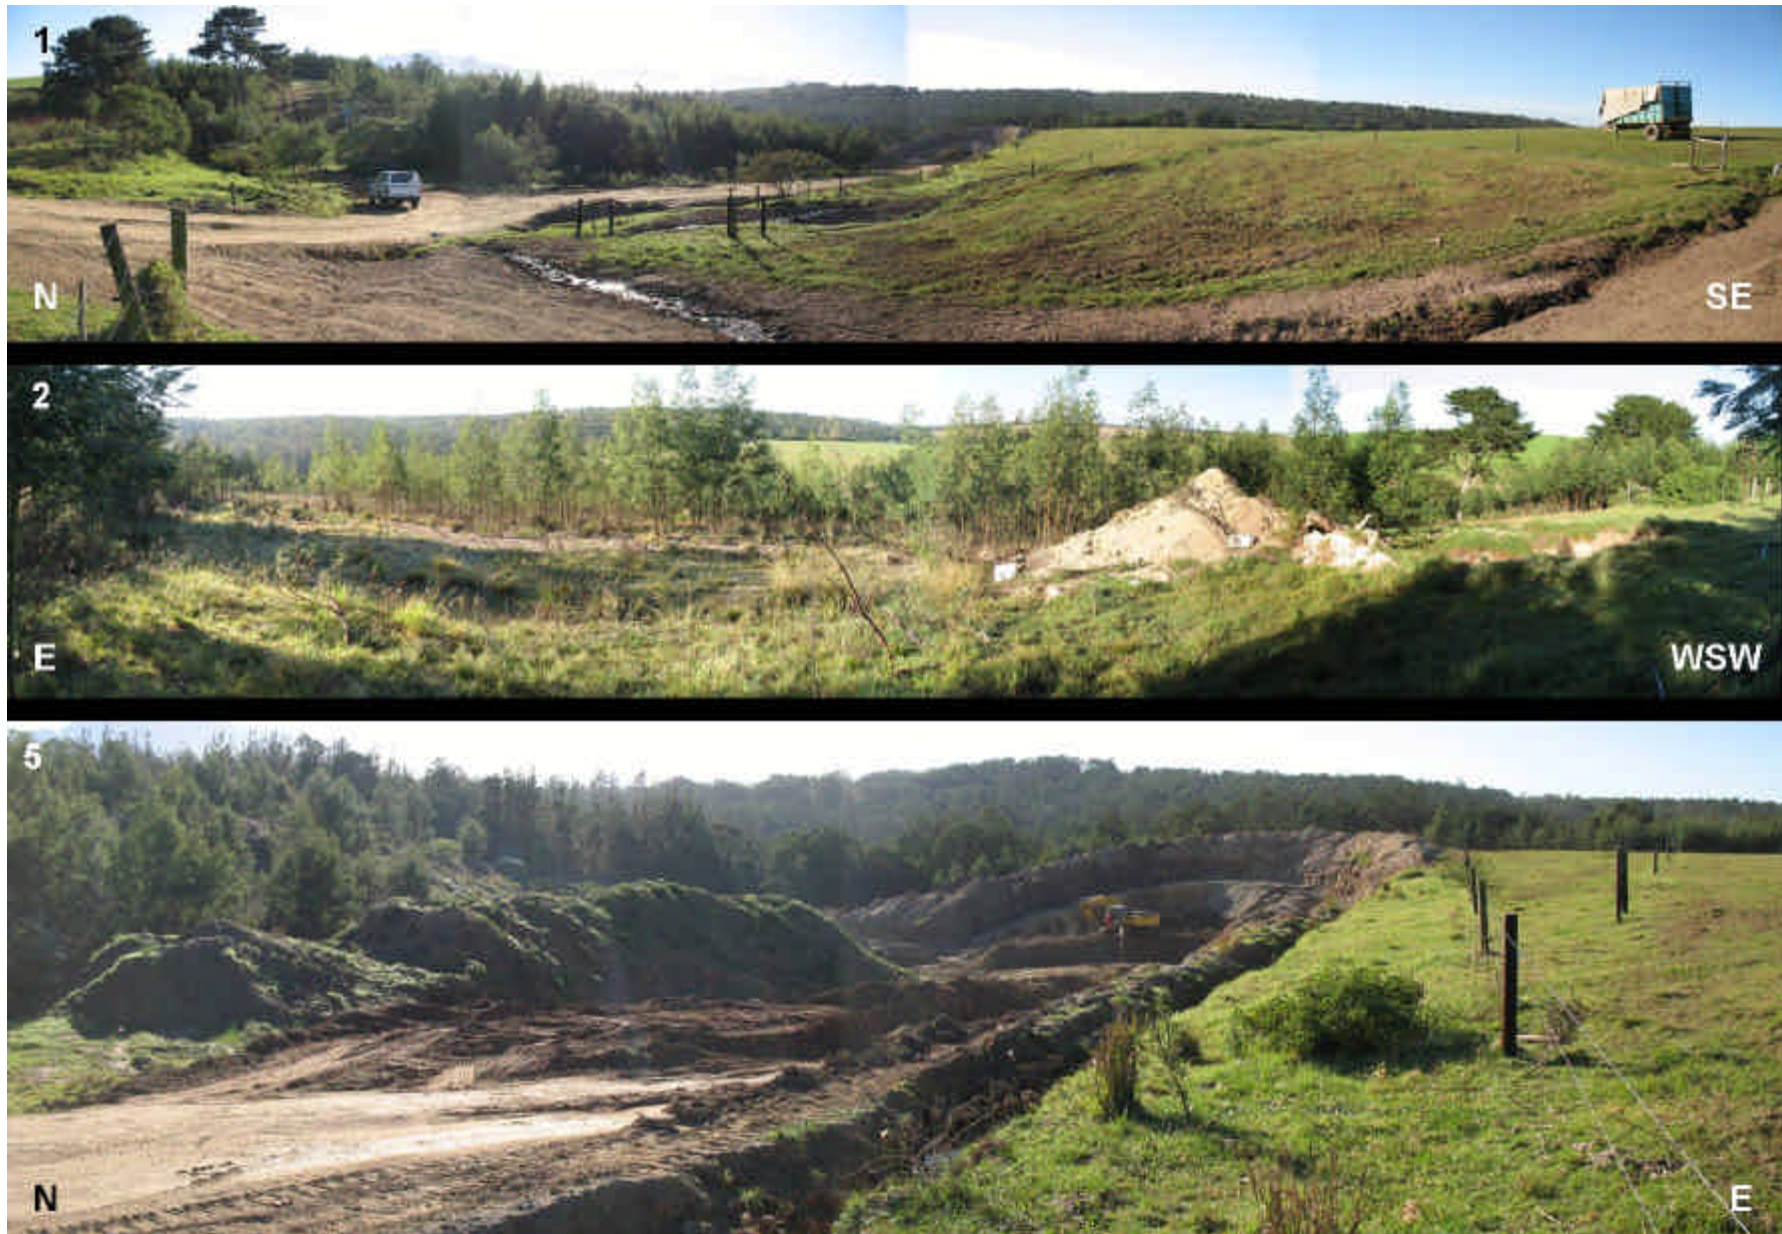
Plate 1. Examples of the surrounding environment, excavations, disturbances, topography and vegetation cover (see Figure 5 and Table 2).

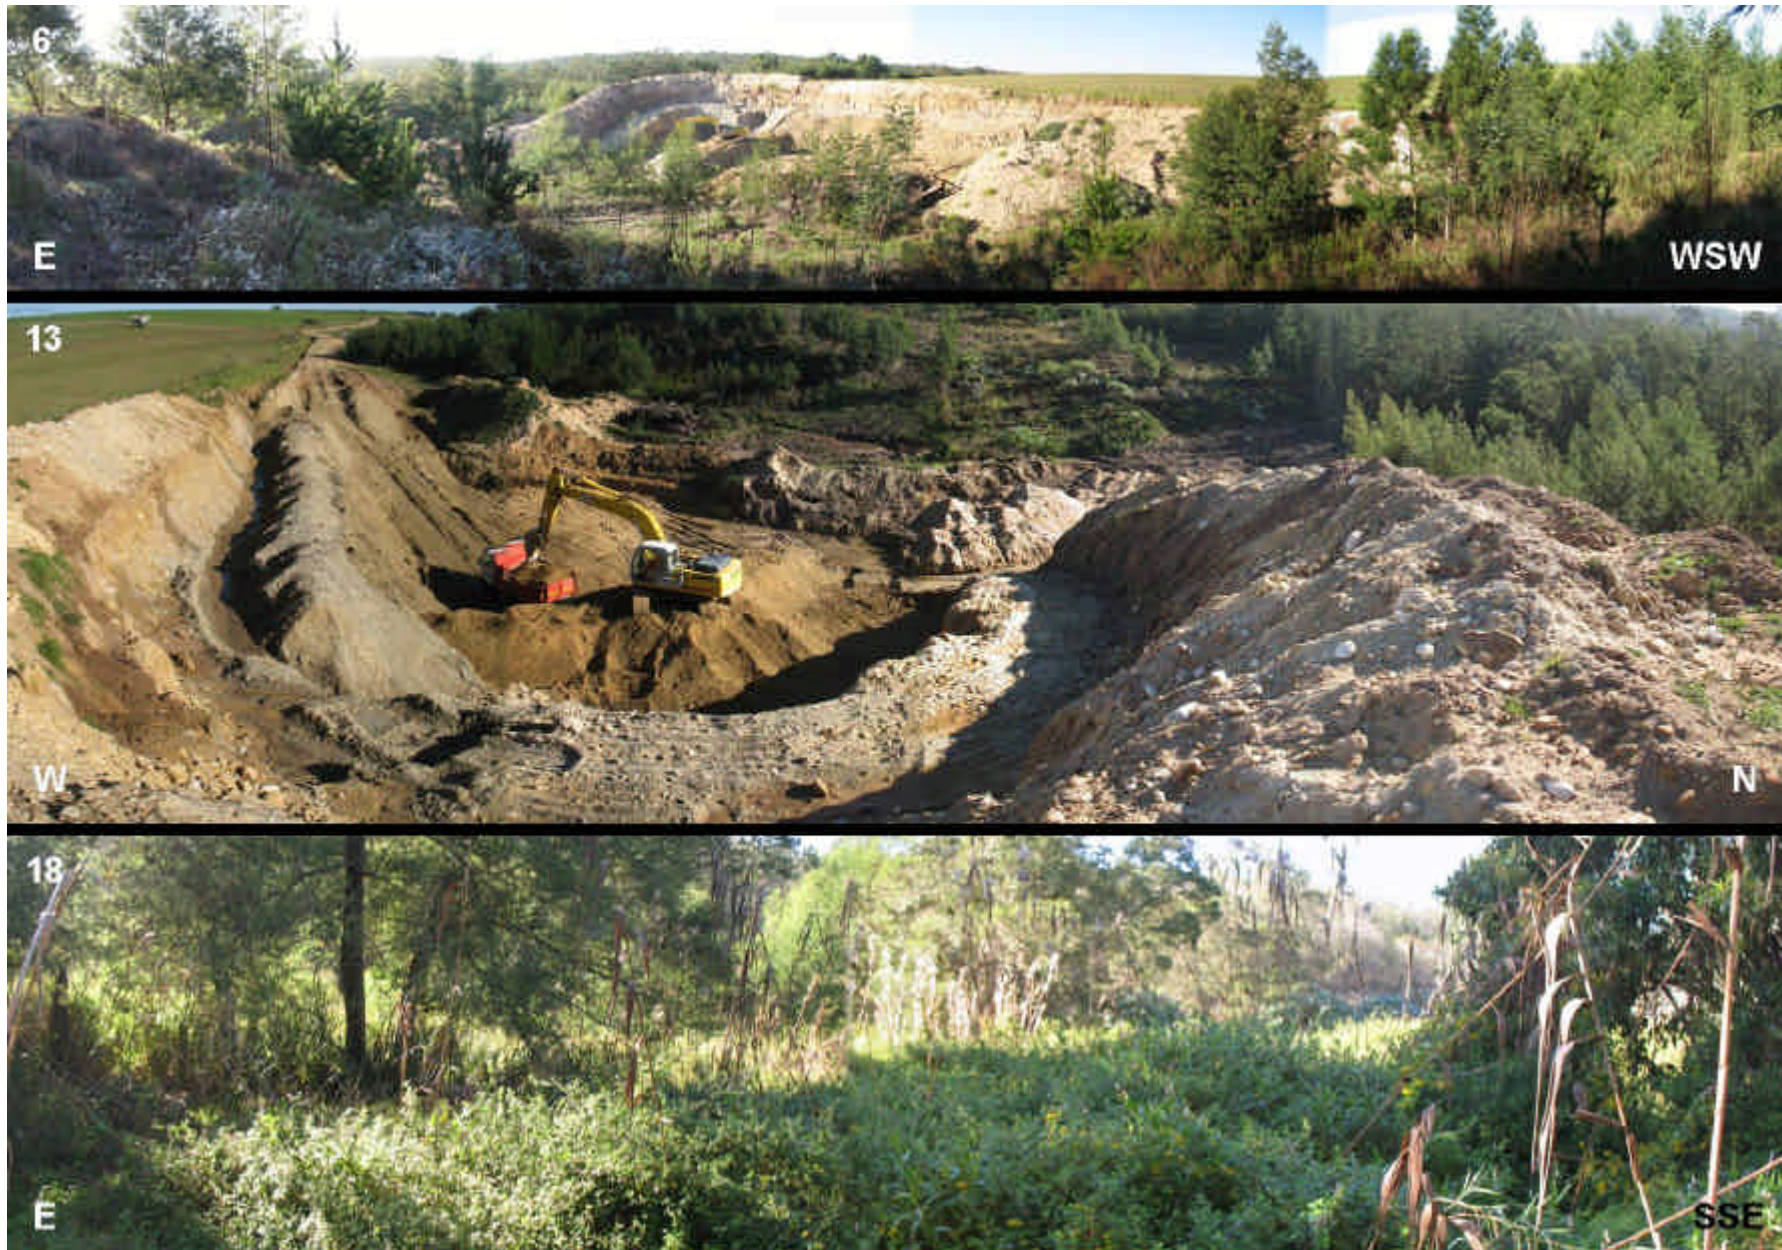
Plate 2. Examples of the surrounding environment, excavations, disturbances, topography and vegetation cover (see Figure 5 and Table 2).

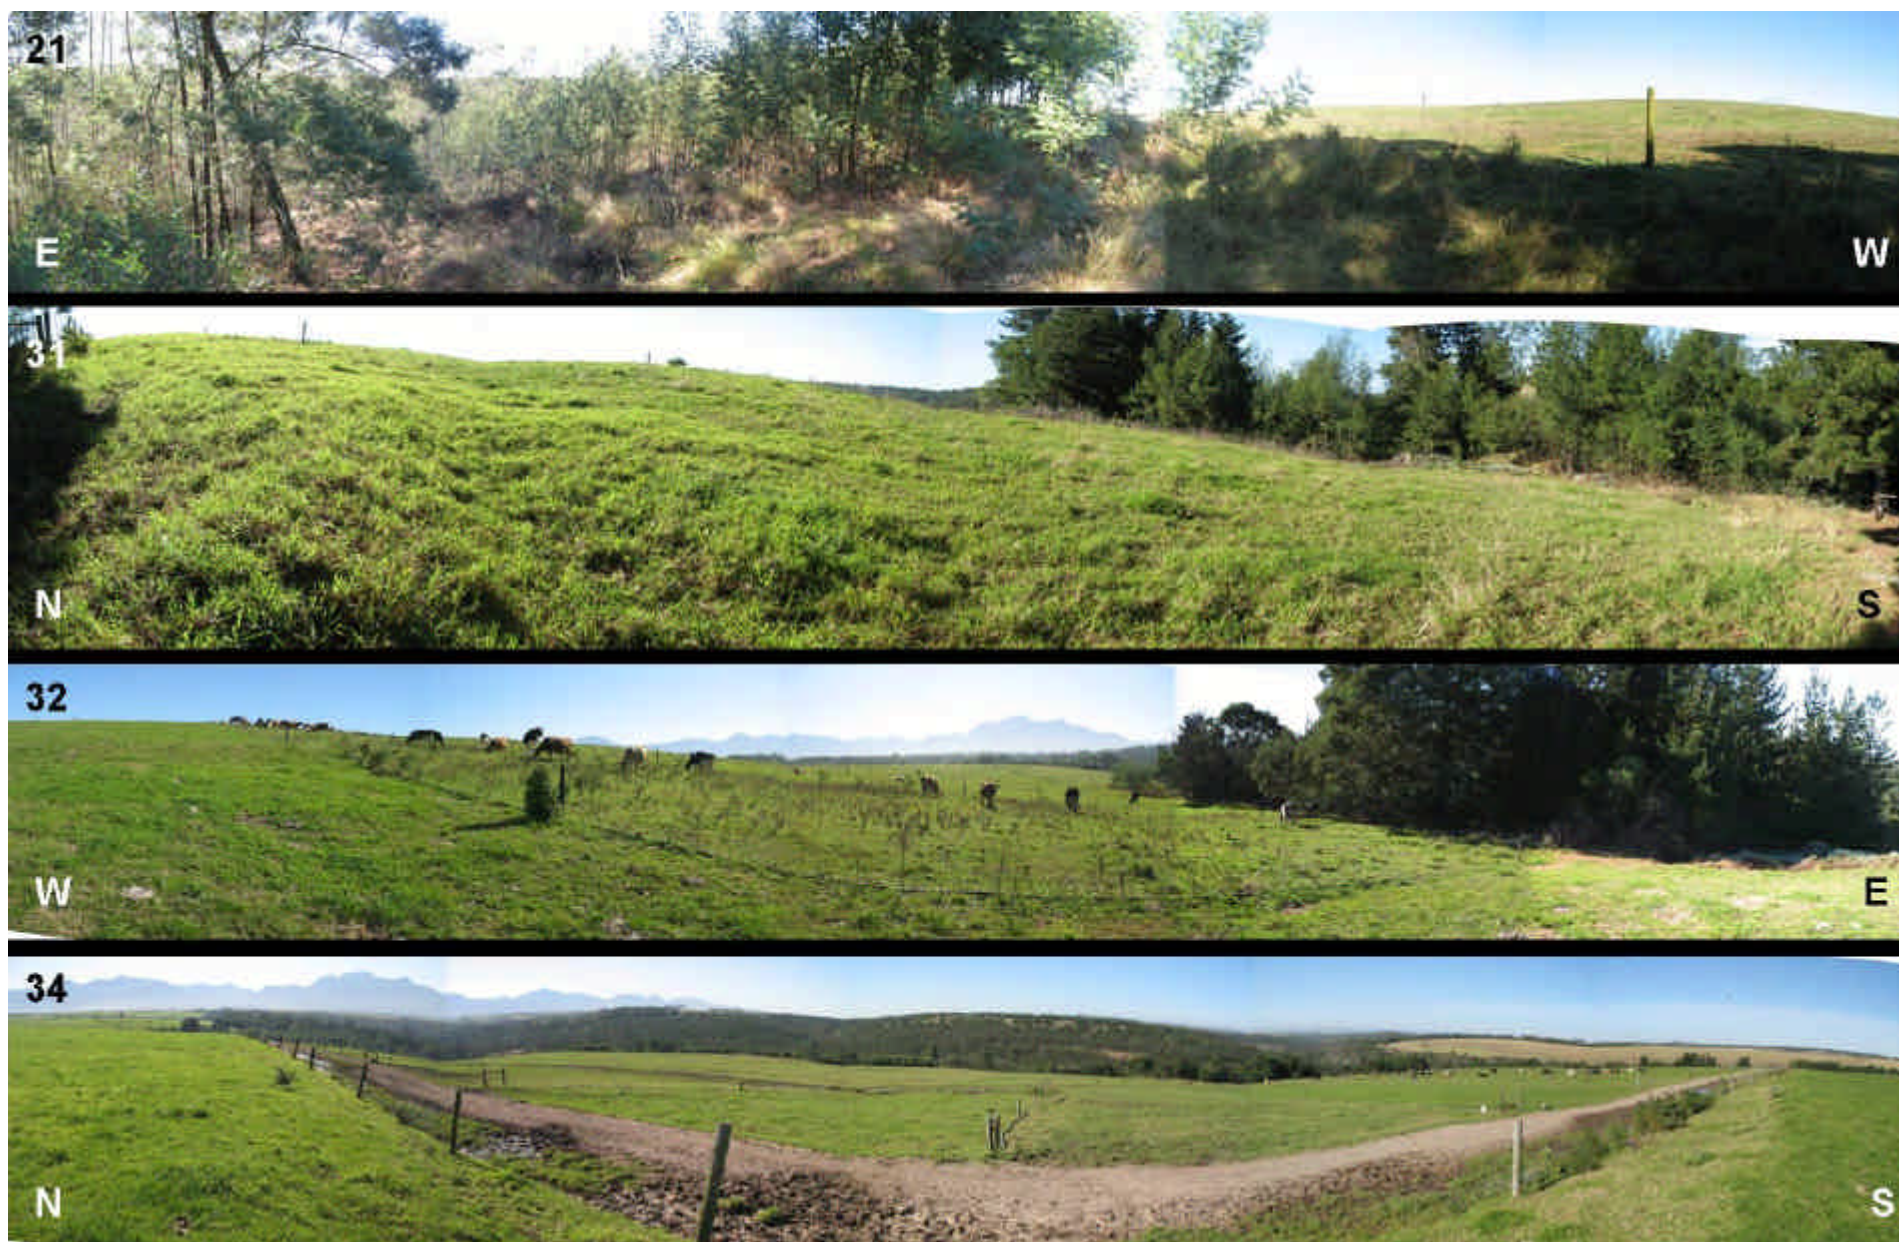
Plate 3. Examples of the surrounding environment, topography and vegetation cover (see Figures 5 & 6 and Table 2).

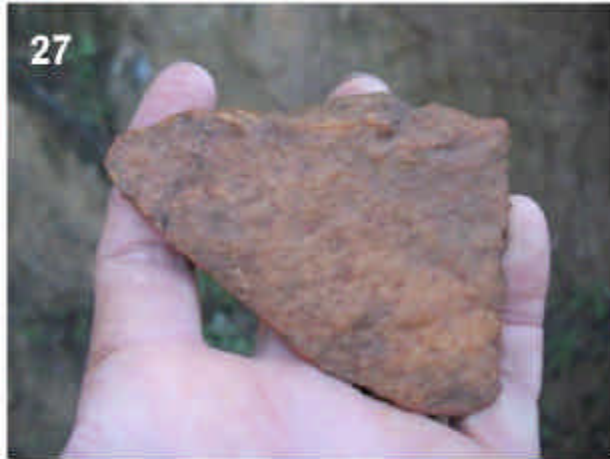
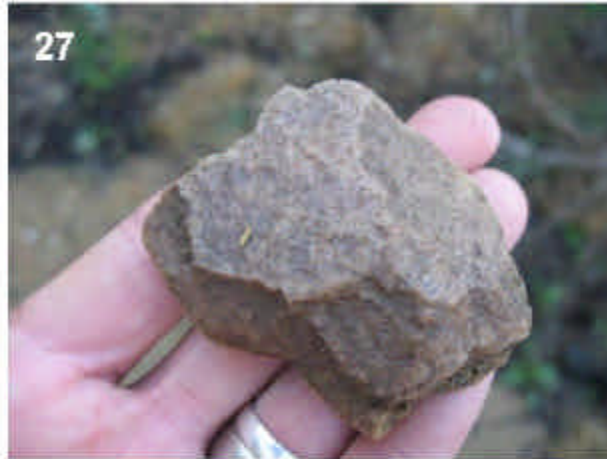
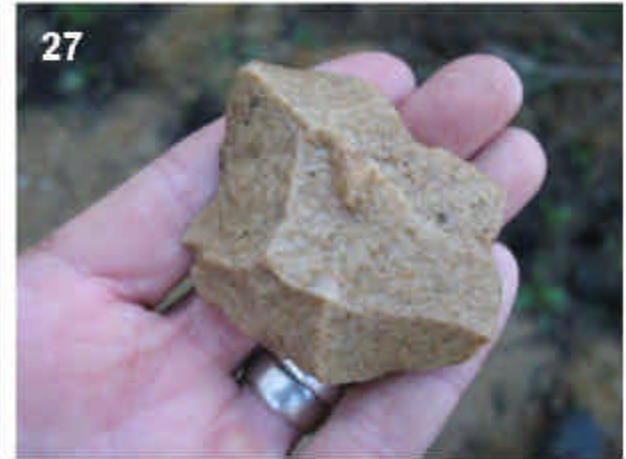
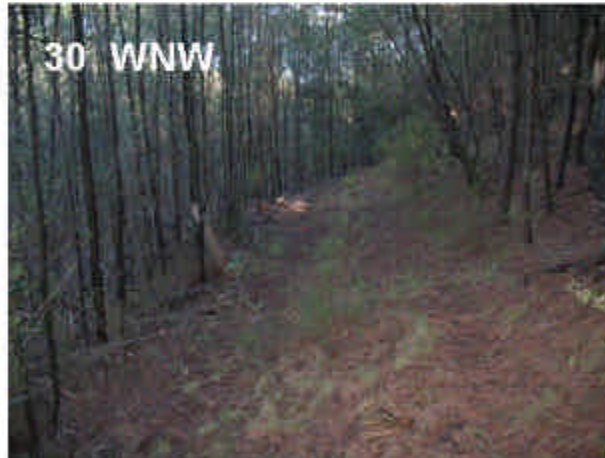
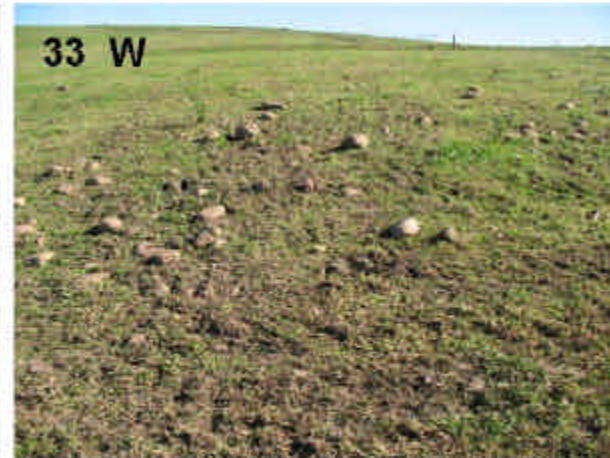
The occurrence at **waypoint 27** is also in a large cutting about midway down the slope to the Gwaing River (Plates 5 & 6). As with waypoint 26, the artefacts seem to be eroded from a thin horizon of water worn stone some 30 to 40cm below ground surface. These are two isolated Middle Stone Age pieces including a large flake and a disc core (Plate 6). Both specimens are in quartzite. It is possible that more artefacts occur here, but will be present in very low frequencies.

Plate 6. Examples of archaeological occurrences, vegetation and an exposure of water worn cobbles (see Figure 6 and Table 2).

For the same reasons as those given above, this occurrence is considered to be of low significance and no further archaeological mitigation is necessary. The proposed activity will not encroach on this part of the study area.
