# Recommendation regarding an Archaeological Impact Assessment

Proposed Desalination Plant, Erven 4117 and 705, Plettenberg Bay,  
Bitou, Eden, Western Cape Province

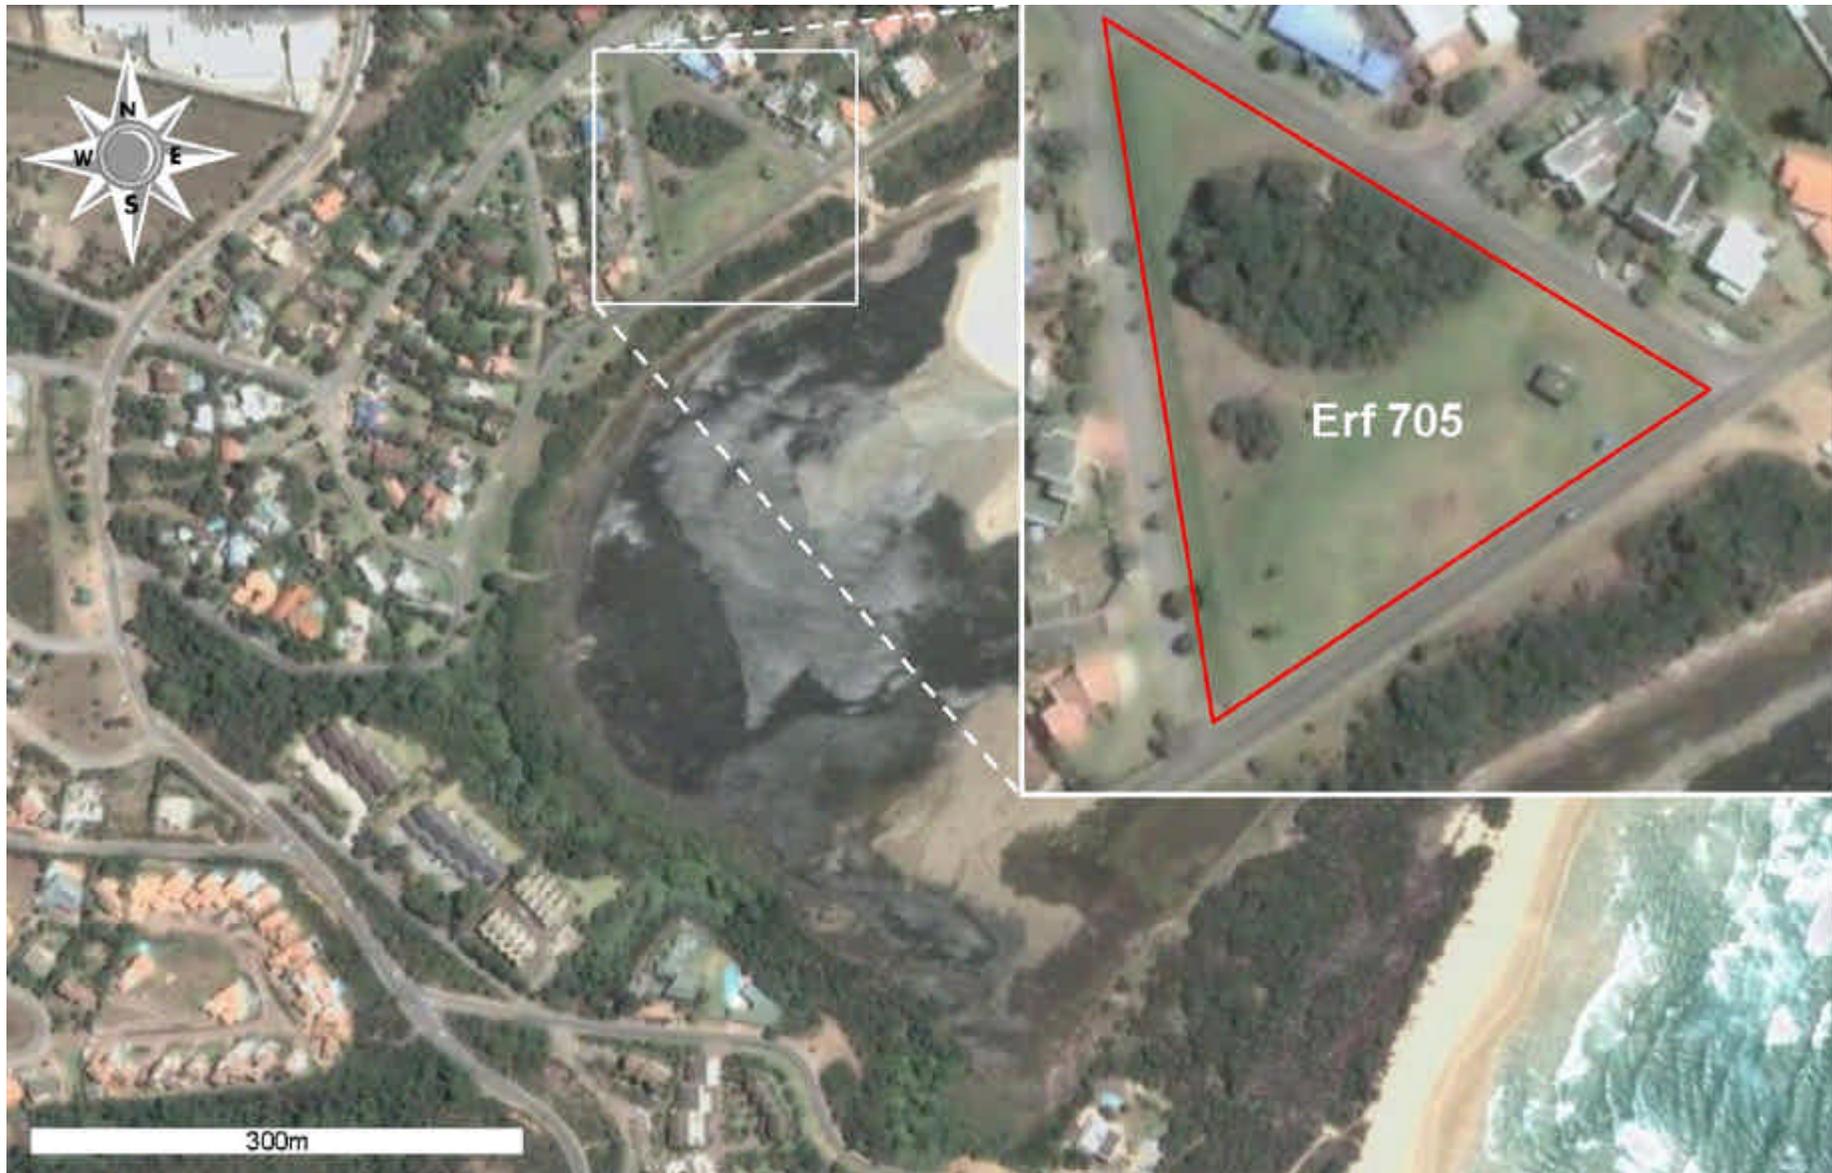
Figure 2. Enlarged area as indicated in Figure 1 showing the location of Erf 705, its proximity to the high water mark, disturbances and vegetation cover (courtesy Google™).

Mr. Killick supplied locality information as well as a photographic record of the site. Erf 705 is situated immediately NW of the SW bank of the Keurbooms River mouth (Figures 1 and 2). The property is covered in grass and disturbances to its sediments include roads, a pump station and associated pipelines (Plate 1). As evidenced by photographs in Plate 1, archaeological visibility is near zero. Vegetation cover on Erf 705 and the area between the road and river to the SE is also shown in Figure 2.

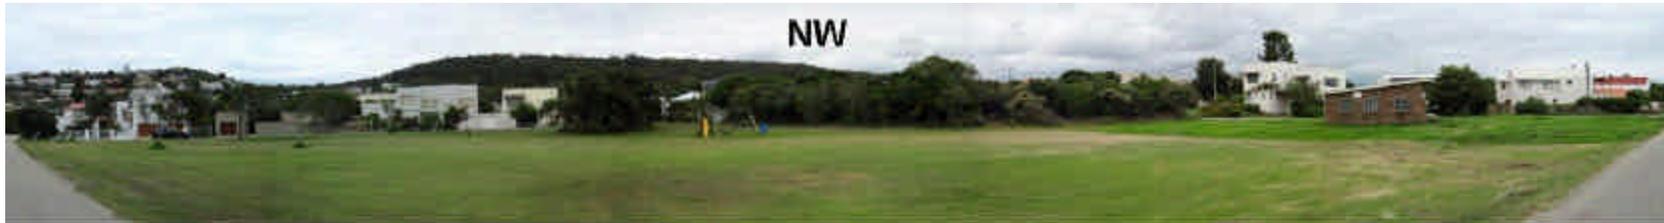
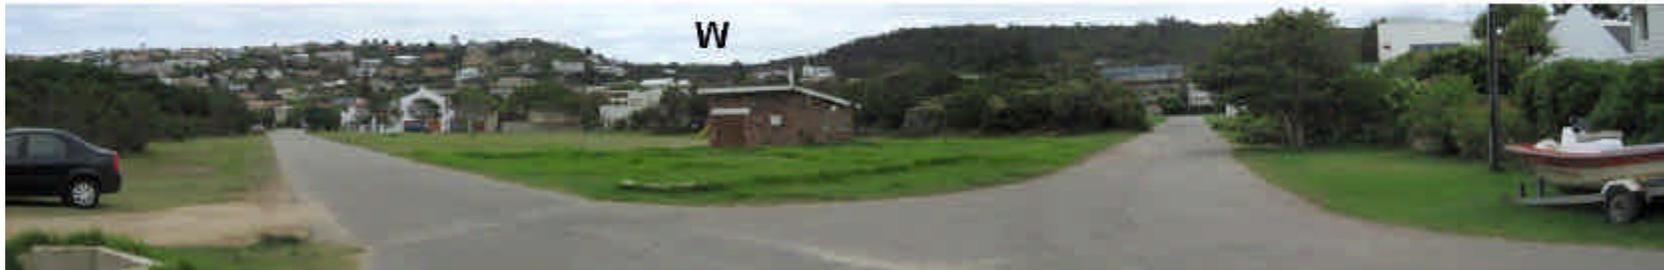
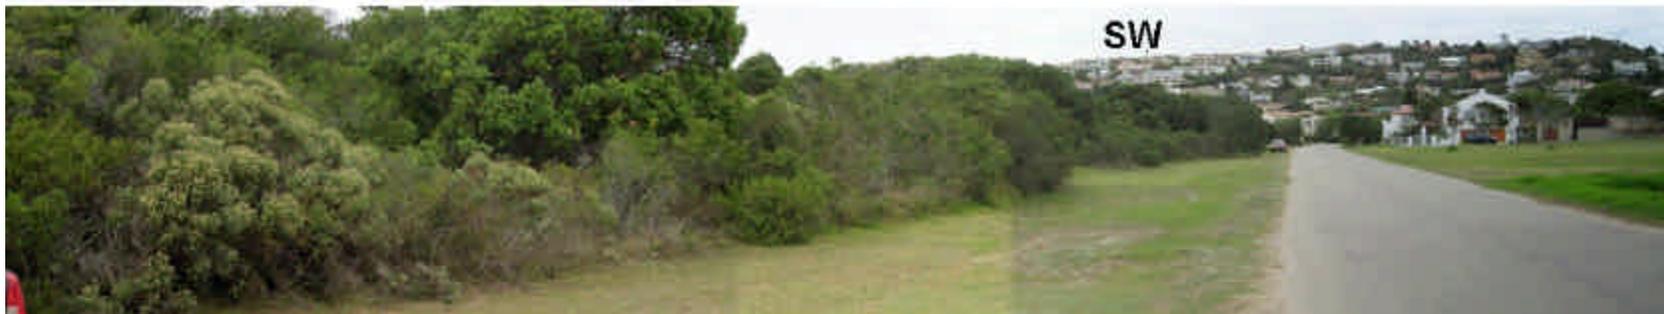
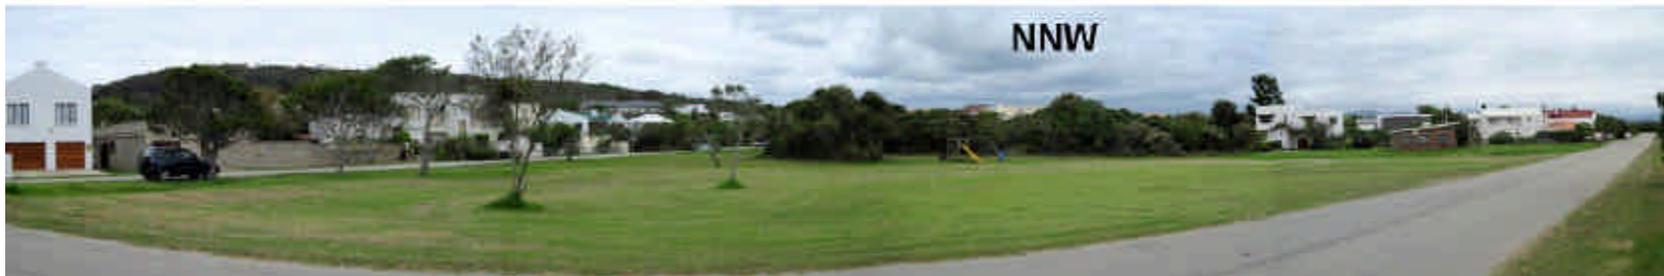
Plate 1. Panoramic views of Erf 705 showing disturbances and vegetation cover. Compass bearing names indicate bearing point in view. (photos courtesy Patrick Killick – Aurecon)

Due to thick grass cover across the property, it is certain that an AIA will conclude that archaeological visibility is inadequate for an assessment, and that archaeological monitoring should be conducted during vegetation clearing and earthmoving activities.

Since it is improbable that Erf 705 will be used for the desalination plant, and because archaeological visibility is severely restricted, it is recommended that an AIA is not required for this property. Nevertheless, should the site be authorised for the proposed activity, it is then recommended that archaeological monitoring be conducted by a professional archaeologist during the vegetation clearing and earthmoving phase of construction. To ensure that this requirement is met, it is recommended that HWC issue a written comment to Aurecon requesting that such requirement be stipulated in the Environmental Management Plan and the DEA&DP's RoD.
